September 1, 2016
2016257.00

RE: Dam Structural Concrete Conditions Assessment

Lower Camp Crowell Lake Dam

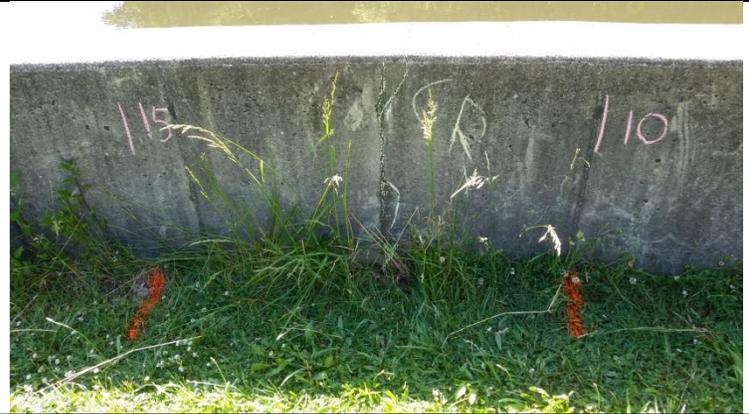
Photo 1

- The concrete "cut off" wall which extends to the west from the Millhouse appears to be generally sound, considering the age of the dam. There are a number of vertical cracks which are indicative of shrinkage cracking due to the lack of control joints in the wall. The portions of the wall that are exposed to the retained lake show some signs of spalling.

The concrete "cut off" wall to the north of the main spillway appears to be in good condition. Cracking in this portion of the dam may be indicative of shrinkage cracking. There is some spalling present on the retained side of the wall below the spillway elevation, which may be indicative of freeze-thaw damage. At this time, we would recommend continued observation of the "cut off" wall concrete for additional signs of distress, with no immediate repairs being required. If repairs to the main spillway concrete are undertaken, repair of cracks should be considered as added scope. As the spalling below the spillway elevation appears to be freeze-thaw induced, we would suggest that the lake be drawn down every fall to reduce the impact of freeze-thaw on the lower portions of the wall.

Concrete "Cut Off" wall. A representative photo of the downstream side of the concrete cut off wall showing cracking (CR) indicative of shrinkage cracks due to no control joints in the wall.

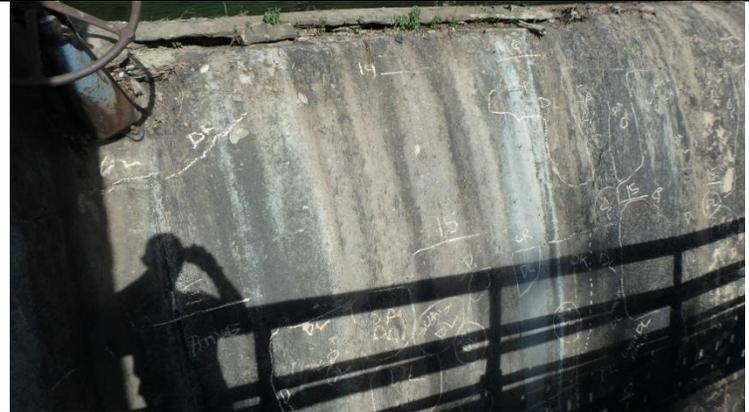
Photo 2

- The ogee spillway concrete surface is in poor condition. The surface shows extensive signs of erosion, with extensive surface pitting, delaminated concrete repairs, and spalls throughout the surface.

Ogee spillway. The top portion of the north end of the ogee spillway. The concrete surface showed signs of spalling (SP), delamination (DL), and cracking (CR).

The ogee spillway concrete showed varying surface conditions. There were areas where previous repairs were made, with some of the repair work showing signs of debonding from the concrete substrate. In some areas the original concrete substrate was spalling away. A concrete core sample was taken from the spillway for petrographic analysis. This concrete core indicated cracking in the repair materials applied in the 1980s. Given the condition of the surface and existing repairs, GPD recommends that the surface of the ogee spillway be repaired. Repair would entail removal of the existing repair materials and a portion of the original concrete down to sound concrete. A repair wire mesh & mortar would be applied to the prepared spillway surface.

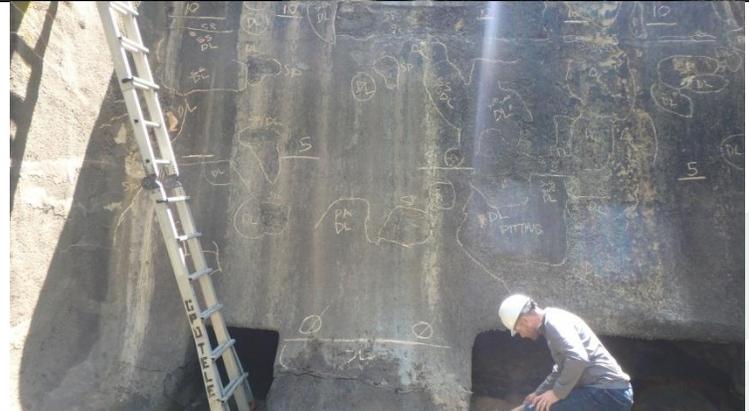
Photo 3

Ogee spillway. The bottom portion of the north end of the ogee spillway. The concrete surface showed signs of spalling (SP), delamination (DL), and cracking (CR).

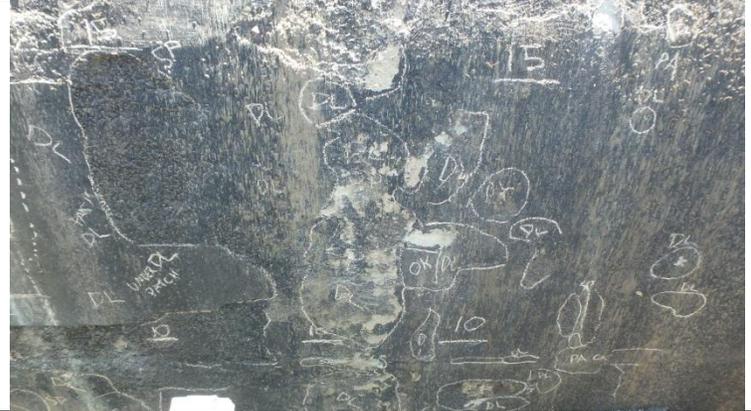
Photo 4

Ogee spillway. The top portion of the center section (directly north of the splash wall) of the ogee spillway. The concrete surface showed signs of spalling (SP), delamination (DL), and cracking (CR).

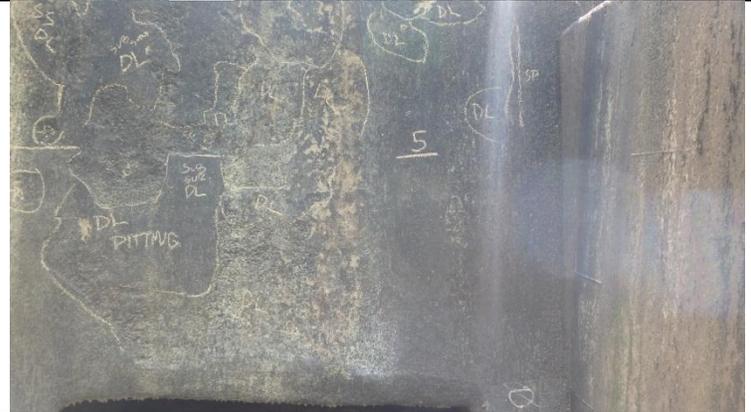
Photo 5

Ogee spillway. The bottom portion of the center section (directly north of the splash wall) of the ogee spillway. The concrete surface showed signs of spalling (SP), delamination (DL), and cracking (CR).

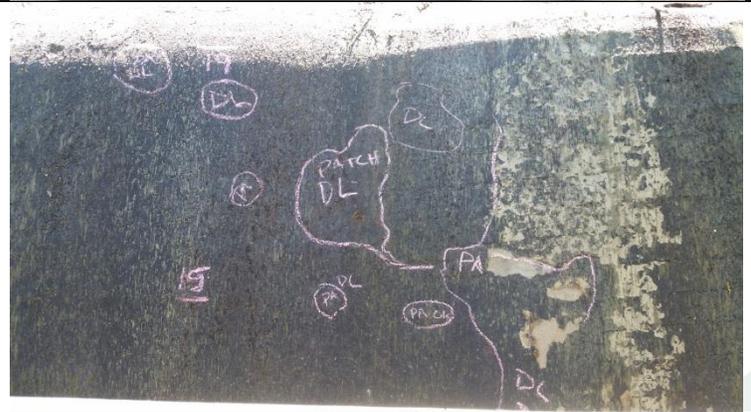
Photo 6

Ogee spillway. The top portion of the east section (directly south of the splash wall) of the ogee spillway. The concrete surface showed signs of spalling (SP), delamination (DL), and cracking (CR).

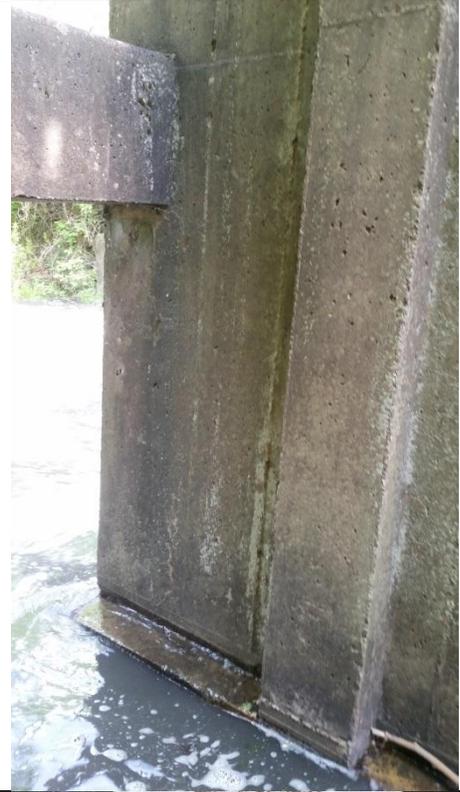
Photo 9

- The splash wall, which was part of the 1979 improvements to the dam, was in good condition. The surface showed some irregularity, but this did not appear to be due to deterioration of the surface.

Splash wall. Representative photo of the splash wall. Some surface imperfection, but generally sound concrete.

The splash wall which was installed during the 1980s appeared to be in good condition. Superficial surface imperfections were observed, but at this time, no repair work should be required.

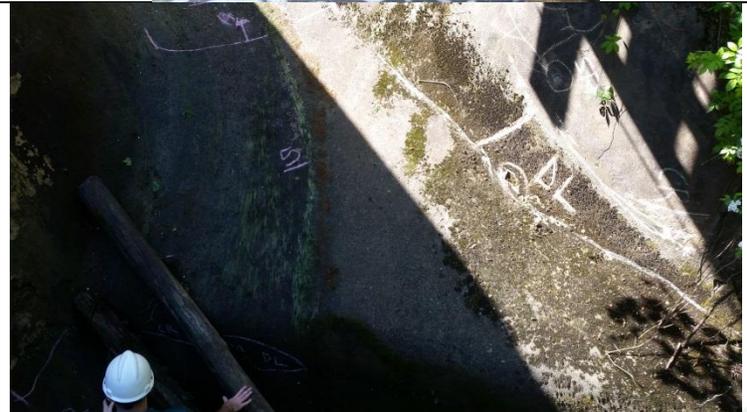
Photo 10

- The chute on the eastern portion of the dam is in poor condition. The surface of the chute showed signs of delaminated concrete on the surface, with cracking throughout. Toward the bottom half of the chute, a hole has opened up, and an area of soil approximately 4'X10' has washed out from underneath the chute. The headwall at the top of the chute shows signs of spalling where it intersects the ogee spillway.

Chute. The bottom portion of the chute. Surface shows signs of delamination (DL), cracking, and spalling (SP).

The chute on the south end of the dam is in poor condition. The concrete condition varies along the length of the chute, with cracking on the vertical surface of the chute, and spalling and delamination present on the bottom surface of the chute. A hole has formed in the chute, with the earth supporting the chute eroding away, leaving a void approximately 4 feet wide by 10 feet long. GPD recommends repair of the chute, but further investigation should be executed to determine the full extent of the repairs needed. At minimum, the vertical surfaces of the chute should be repaired, with existing repair material and original concrete removed down to sound concrete. A concrete core taken from the chute wall indicates freeze-thaw distress down to 7 inches below the surface. GPD recommends that the concrete be removed to at least this depth for surface preparation. The thickness of the existing chute walls was unknown to GPD at the time of this inspection, and further investigation of the chute could lead to a recommendation of full removal and replacement of the chute. Additional core samples should be taken to determine the original thickness of the concrete structure to determine if a surface repair will be effective, or if full removal or replacement is required. In addition, the void that has formed below the chute requires attention. All loose material that has been weakened by washing out of the soil over time should be removed, the void should be filled with lean concrete, and the chute atop this fill should be repaired.

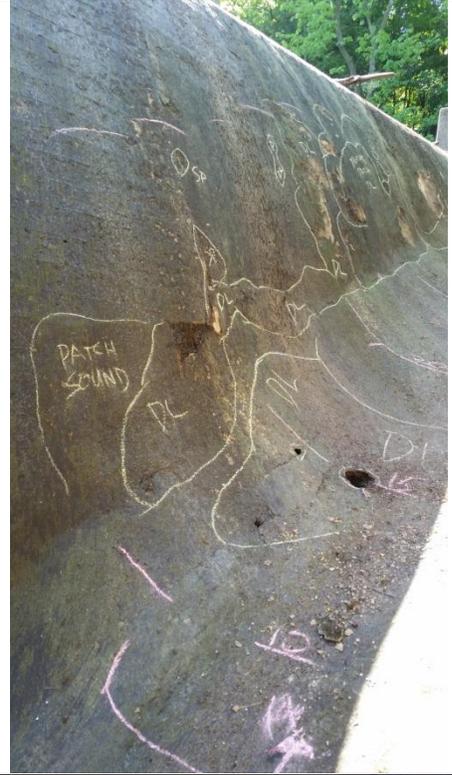
Photo 11

Chute. The lower center portion of the chute looking to the east wall of the chute. Surface shows signs of delamination (DL), cracking, and spalling (SP). Note the hole in the bottom of the chute near the 15' mark. The arrow at the bottom of the photo represents the approximate lower extent of the void below the chute.

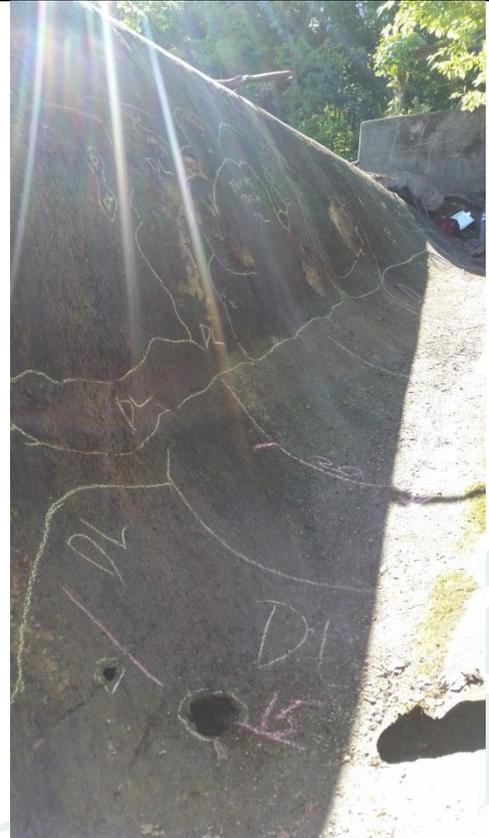
Photo 12

Chute. The upper center portion of the chute looking to the east wall of the chute. Surface shows signs of delamination (DL), cracking, and spalling (SP). Note the hole in the bottom of the chute near the 15' mark.

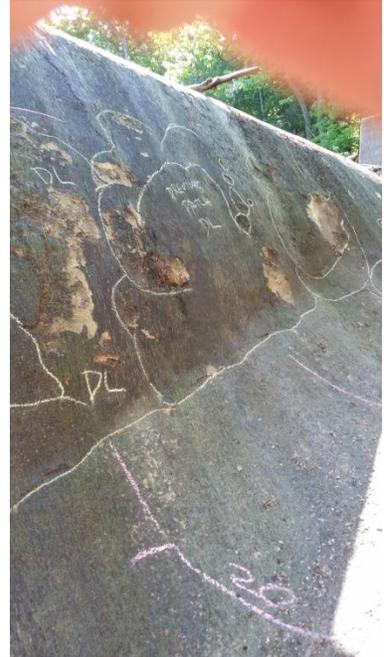
Photo 13

Chute. The upper portion of the chute looking to the east wall of the chute. Surface shows signs of delamination (DL), cracking, and spalling (SP).

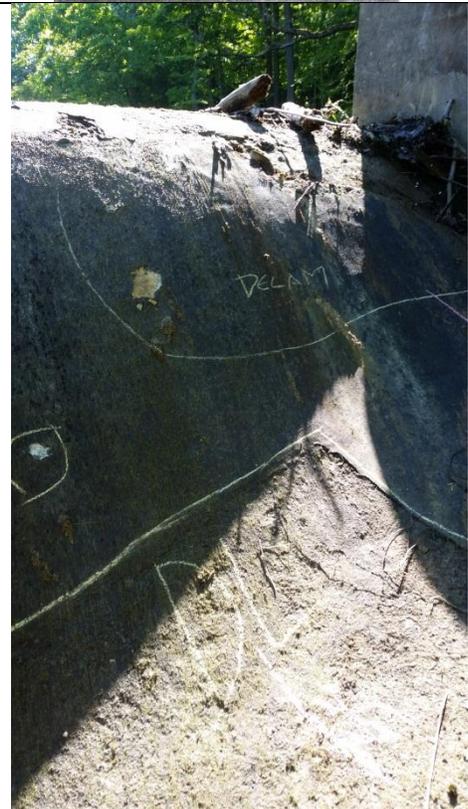
Photo 14

Chute. The top of the chute looking to the east wall of the chute. Surface shows signs of delamination (DL), cracking, and spalling (SP).

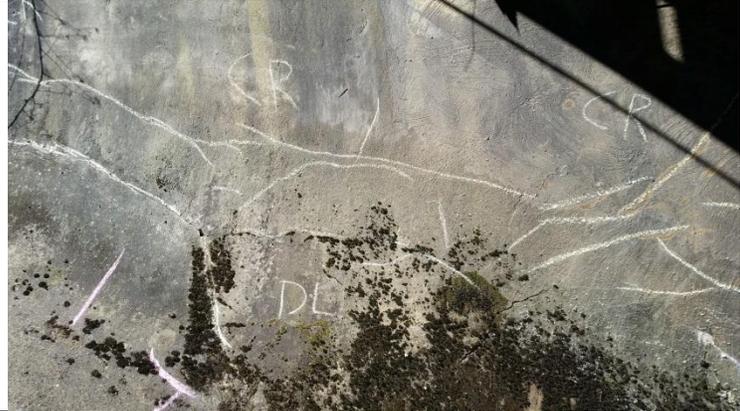
Photo 15Description:

Chute. A representative photo of the lower portion of the west wall of the chute. The surface shows signs of delamination (DL), cracking (CR).

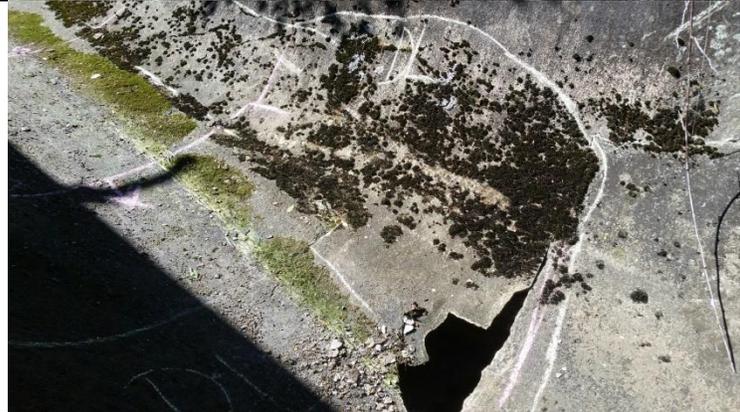
**Photo 16**Description:

Chute. A photo of the west wall of the chute. The surface shows signs of delamination (DL), cracking (CR). Notice the opening in the bottom of the chute in the foreground of the photo.

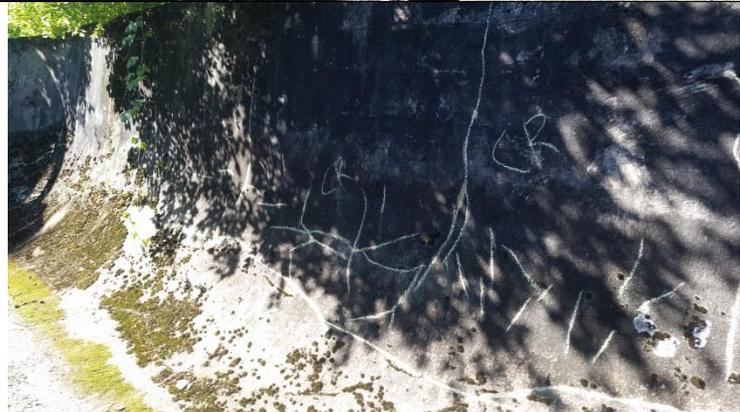
**Photo 17**Description:

Chute. A representative photo of the upper portion of the west wall of the chute. The surface shows signs of delamination (DL), cracking (CR).

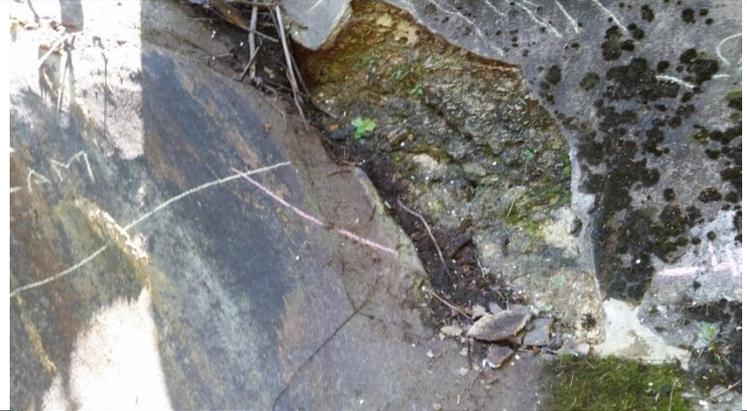
Photo 18Description:

Chute. Spall at the top of the chute.

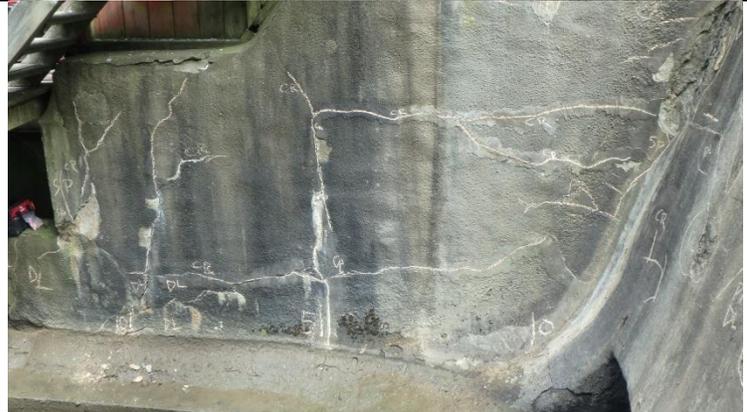
**Photo 19**Description:

- The wall supporting the south wall of the millhouse is in fair to poor condition. The outside face of the wall has repair mortar on the surface, which showed signs of cracking. The repair material on the inside face of the wall showed signs of debonding from the original substrate. A concrete core was taken from the inside of the wall. The portion of the wall nearest the wheel showed greater

Millhouse. Lower portion of the outside face of the south millhouse wall. Wall shows signs of cracking (CR), delamination (DL), and spalling (SP).

The millhouse foundation walls are in fair to poor condition. The south wall supporting the millhouse showed signs of cracking in the previously made surface repairs, and the original substrate showed signs of freeze-thaw damage to depths of approximately 4 inches on the interior face of the wall. The wall supporting the east wall of the millhouse is in fair condition, with prior surface repairs debonding from the original concrete. GPD recommends that the millhouse walls be repaired, with further investigation required to determine the extent of the repairs. For a surface repair, extensive amounts of concrete would need to be removed, and this further investigation could lead to the recommendation that the south wall be removed in its entirety and replaced. This would cause some challenges as the millhouse sits atop these walls, and support of the millhouse during replacement would need to be designed.

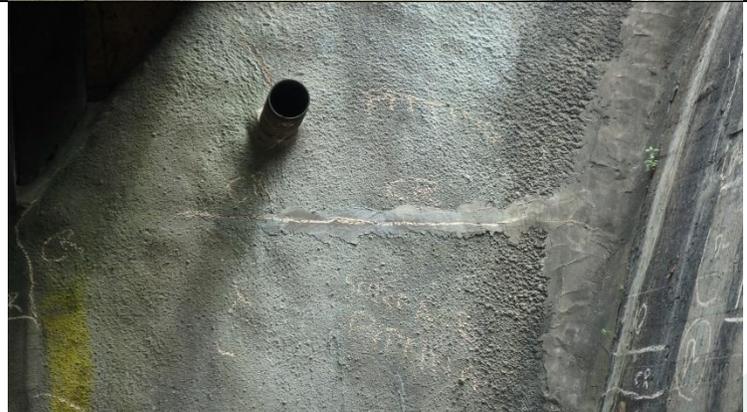
**Photo 20**Description:

Millhouse. Upper portion of the outside face of the south millhouse wall. Wall shows signs of cracking (CR), delamination (DL), and pitting. Portions of the wall above this level were not accessible by ladder.

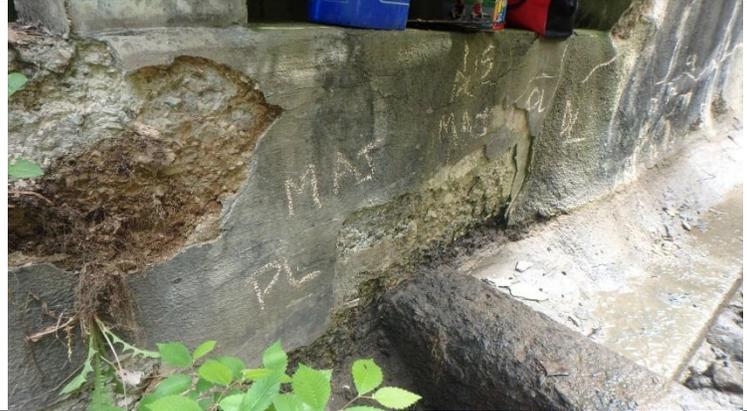
Photo 21

signs of distress, with surface spalling, and debonding of repair material. Weeds were found to be growing in cracks in the wall.

Millhouse. Portion of the wall below the lower patio of the millhouse between the wheel and millhouse. Wall shows delamination (DL) and spalling. The substrate is eroding, and vegetation is growing in the spalls and cracks.

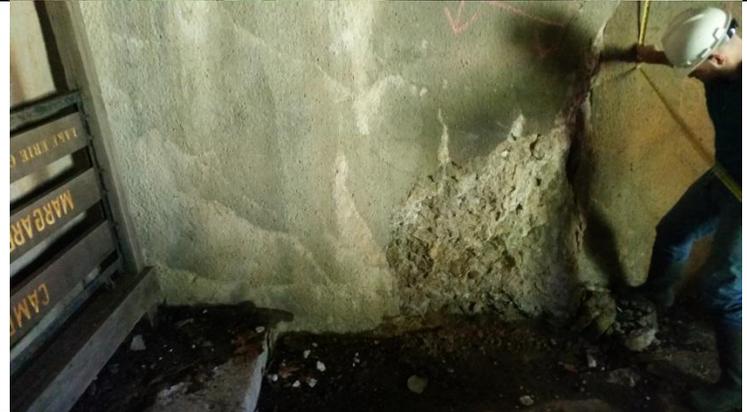
Photo 22

Millhouse. Lower portion of the interior surface of the south millhouse wall. Wall shows delamination of surface repairs as well as heavy deterioration of the substrate.

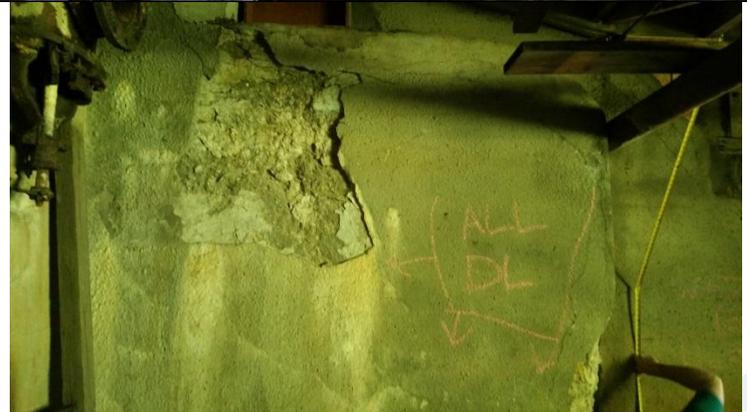
Photo 23

Millhouse. Upper portion of the interior surface of the south millhouse wall. Wall shows delamination of surface repairs as well as heavy deterioration of the substrate.

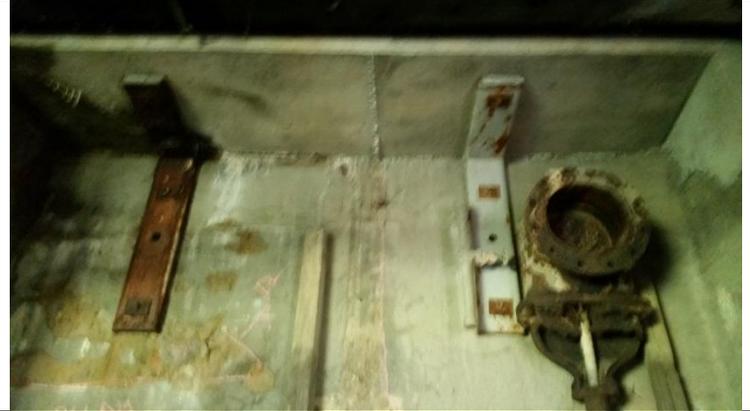
Photo 24

- The wall supporting the east wall of the millhouse is in fair condition. There are previous surface repairs that show signs of debonding from the original substrate. It should also be noted that there is a visible gap at the top of the wall below the wood patio that allows rainfall surface runoff water to enter the basement of the millhouse.
- While the level of the lake was lowered to allow inspection of the spillway surface, the upstream side of the dam was not accessible and was not inspected at the time of our visit.
- The hollow areas of the dam below the ogee spillway were not accessible, and were not inspected.

Millhouse. Upper portion of the interior surface of the east millhouse wall. Wall shows delamination of surface repairs.
