GPD GROUP®
Glaus, Pyle, Schomer, Burns & DeHaven, Inc.

September 1, 2016
2016257.00

RE: Dam Structural Concrete Conditions Assessment – Upper Hilaka Lake Dam

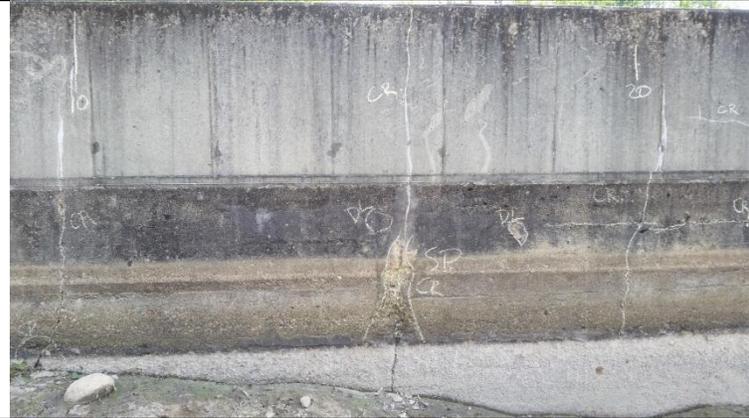
APPENDIX: REPRESENTATIVE PHOTOS OF THE UPPER HILAKA LAKE DAM:**Photo 1****Description:**

The concrete "cut off" wall to the west of the main spillway appears to be in good condition. Cracking in this portion of the dam is indicative of shrinkage cracking. There is some spalling present below the spillway elevation, which may be indicative of freeze-thaw damage. There is some delamination and surface spalling above the spillway present, but this damage is superficial and minor in nature. At this time, we would recommend continued observation of the "cut off" wall concrete for additional signs of distress, with no immediate repairs being required. If repairs to the main spillway concrete are performed, repair of spalls and cracks should be considered as added scope. As the spalling below the spillway elevation appears to be freeze-thaw induced, we would suggest that the lake be drawn down every fall to reduce the impact of freeze-thaw on the lower portions of the wall.

Concrete "Cut Off" wall. A representative photo of the lake side of the concrete cut off wall showing cracking indicative of shrinkage cracks (CR) due to no control joints in the wall as well as spalling (SP) near the spillway elevation.

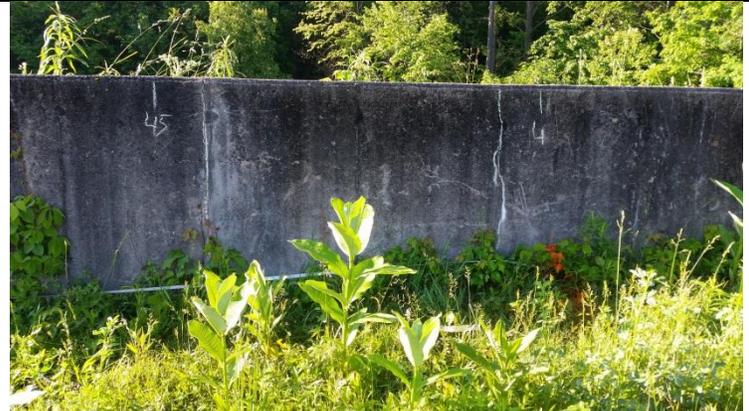
**Photo 2****Description:**

Concrete "Cut Off" wall. A representative photo of the lake side of the concrete cut off wall, with the entire concrete portion of wall above the spillway elevation. Wall shows signs of vertical cracks indicative of shrinkage cracking due to no control joints in the wall.

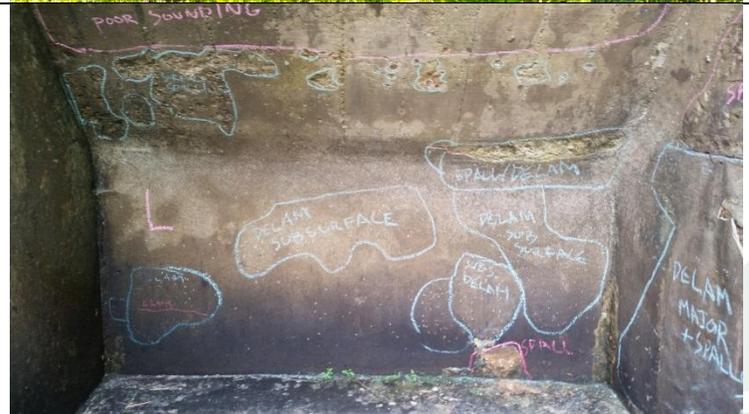
**Photo 3****Description:**

Main Spillway – Lower half of westernmost cell. The vertical and sloping surface of the spillway showing surface spalls, delamination, and some cracking.

The spillway concrete showed varying surface conditions. There were areas where previous repairs were made, with some of the repair work showing signs of debonding from the concrete substrate. Other areas appeared to be generally sound. There were some signs of seepage through cracks in the spillway. Petrographic analysis of a core sample taken through the spillway showed few signs of erosion, and low levels of chlorides. GPD recommends that the sloped and vertical surfaces of the spillway downstream of the lake be repaired. Repair would require removal of the existing surface concrete down to sound concrete, with a repair wire mesh & mortar applied to the prepared surface.

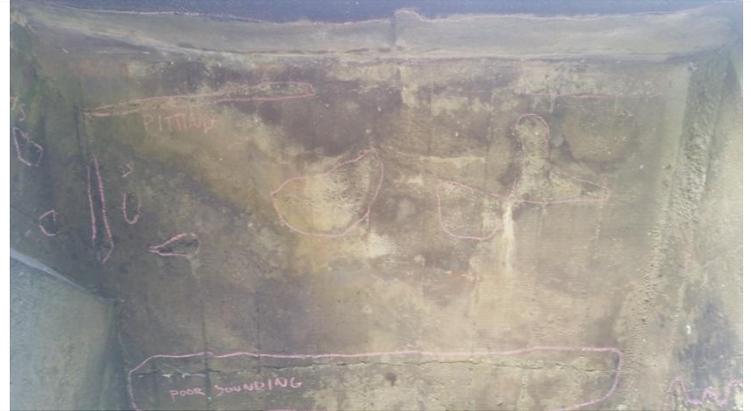
Photo 4

Main Spillway – Upper half of westernmost cell. The sloping surface of the spillway showing surface spalls, delamination, and a large horizontal crack across the cell.

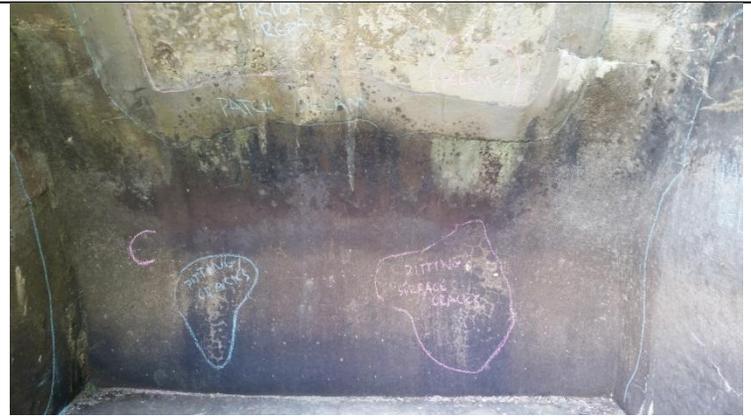
Photo 5

Main Spillway – Lower half of center cell. The vertical and sloping surface of the spillway showing surface pitting and cracks as well as a prior repair showing signs of delamination and debonding from the original substrate.

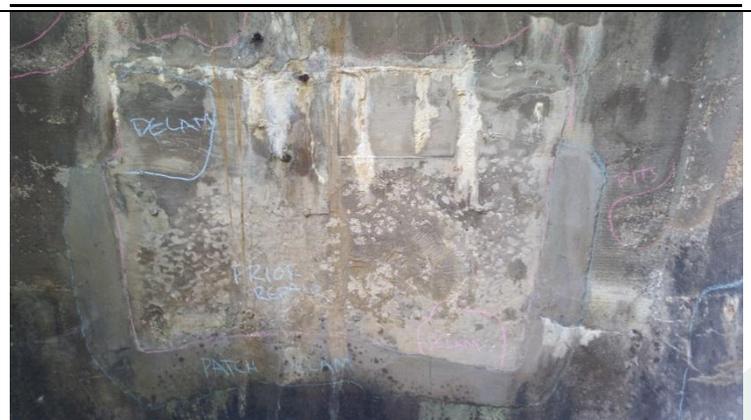
Photo 6

Main Spillway – Upper half of center cell. The sloping surface of the spillway showing surface pitting as well as a prior repair showing signs of delamination and debonding from the original substrate.

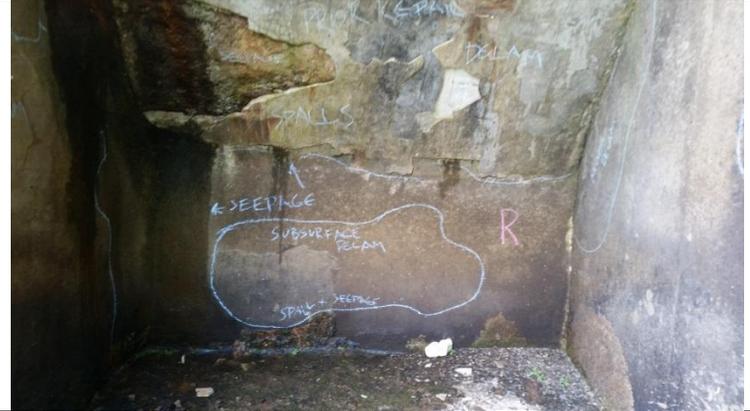
Photo 7

Main Spillway – Lower half of easternmost cell. The vertical and sloping surface of the spillway showing surface delamination and spalling. Seepage is visible in this portion of the spillway.

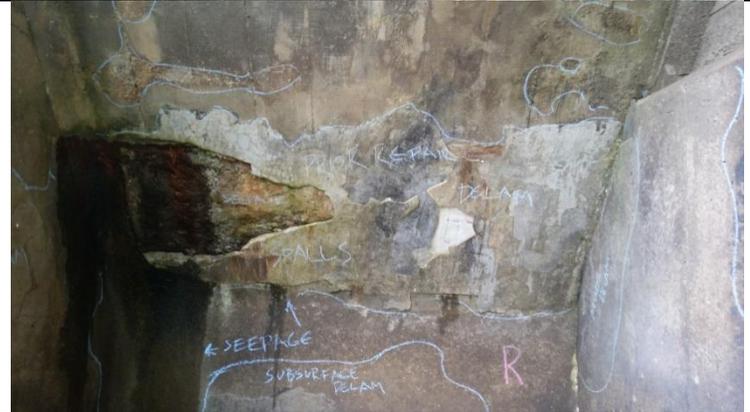
Photo 8

Main Spillway – Center portion of easternmost cell. The vertical and sloping surface of the spillway showing surface delamination of a prior repair and spalling. Seepage is visible in this portion of the spillway.

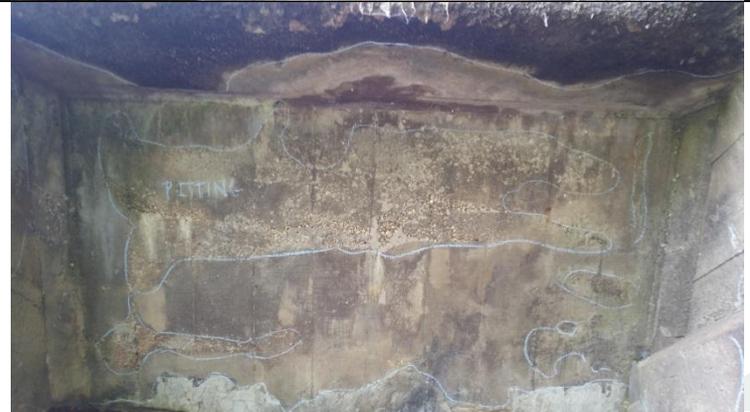
Photo 9

Main Spillway – Upper half of easternmost cell. The sloping surface of the spillway showing surface pitting.

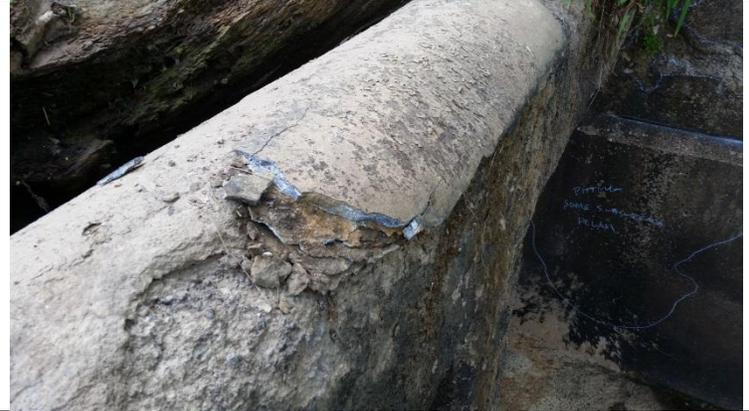
Photo 10

Main Spillway – Top of spillway. The top surface of the spillway shows signs of freeze thaw damage, with repair material debonding from the original substrate and damage to the original concrete. The vertical surface shows signs of surface pitting and erosion.

The top of the spillway wall showed signs of freeze-thaw damage to the substrate concrete and to previous repairs. Some portions of the top of the spillway have old repairs still in place, but through hammer sounding of the concrete, appear to be debonding from the substrate. GPD recommends that the top portion of the dam spillway be repaired. Similar to the face of the spillway wall, the existing surface would be removed down to sound concrete, and a repair wire mesh & mortar would be applied to the prepared surface. Further, we recommend that the cracks through which water is seeping be repaired and monitored for further seepage.

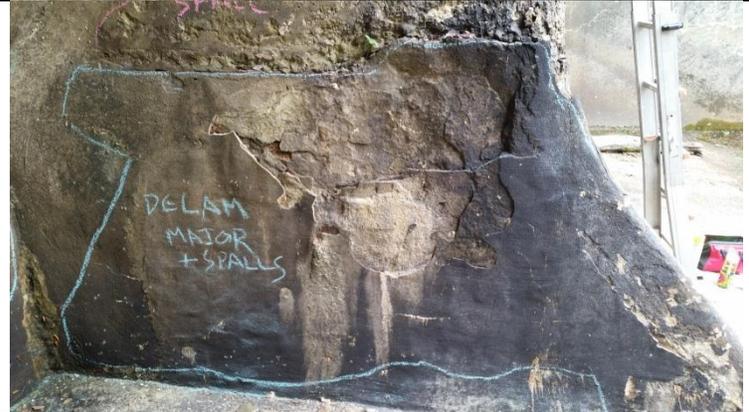
Photo 11

Main Spillway – West Buttress Wall. The bottom portion of the west buttress wall shows signs of delamination and spalling. The original concrete substrate is heavily distressed.

The two buttress walls of the spillway are in poor condition. Previous surface repairs were in very poor condition, with large areas of repaired concrete debonding from the original substrate. Spalling occurs throughout the buttress walls, and there is corroded wire mesh exposed. A core sample through one of the buttress walls shows signs of freeze-thaw damage, as well as signs of moisture intrusion through the entire width of the wall. GPD recommends that the buttress walls be removed and replaced with new reinforced concrete walls of adequate design. The existing concrete shows signs of freeze-thaw damage down to approximately 4-5" below the surface. Removal of this concrete alone could expose concrete sound enough to apply repair material. However, a repair of this depth would likely necessitate reinforcing being added to the repair, which would be embedded into the existing substrate. Due to the age of the existing concrete, embedding reinforcing into the

existing concrete and bonding it to new concrete would likely create a cathodic cell, and damage to the repair due to corrosion would be accelerated. Our recommendation to remove the whole buttress walls minimizes the risk of recurring repairs being required.

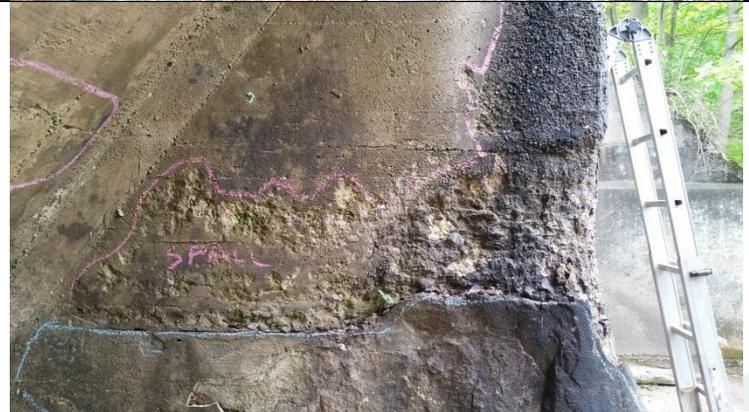
Photo 12

Main Spillway – West Buttress Wall. The middle portion of the west buttress wall shows signs of spalling and cracking. The original concrete substrate is heavily distressed.

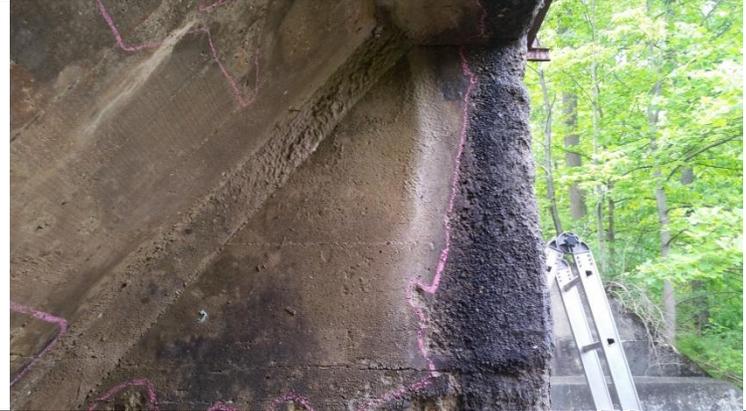
Photo 13

Main Spillway – West Buttress Wall. The upper portion of the west buttress wall shows signs of spalling and cracking. The original concrete substrate is heavily distressed.

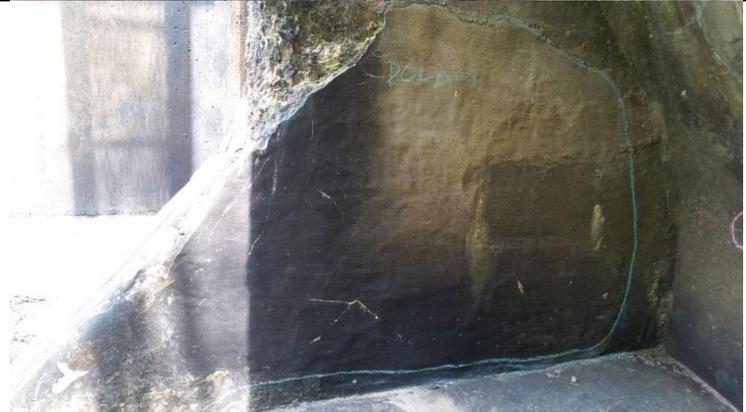
Photo 14

Main Spillway – West Buttress Wall. The bottom portion of the west buttress wall shows signs of delamination and spalling. The original concrete substrate is heavily distressed.

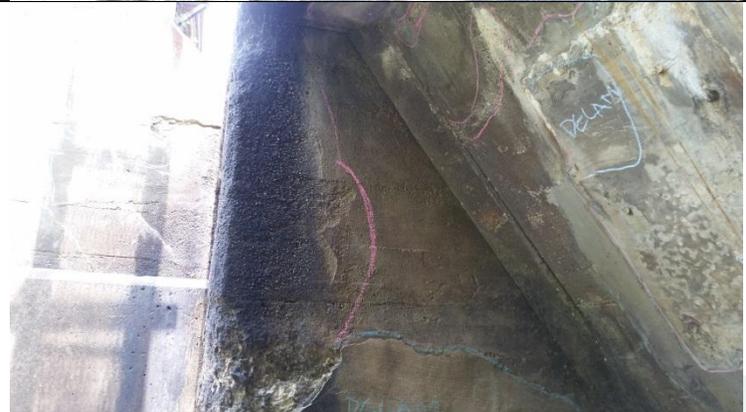
Photo 15

Main Spillway – West Buttress Wall. The upper portion of the west buttress wall shows signs of spalling and cracking. The original concrete substrate is heavily distressed.

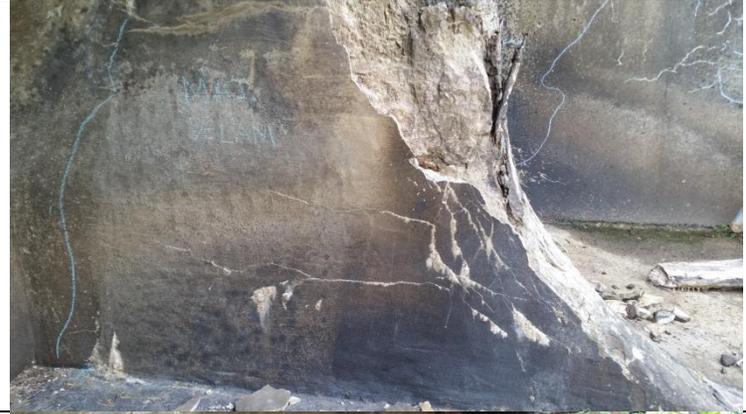
Photo 16

Main Spillway – East Buttress Wall. The bottom portion of the east buttress wall shows signs of delamination and spalling. The original concrete substrate is heavily distressed. Wire mesh reinforcing is exposed.

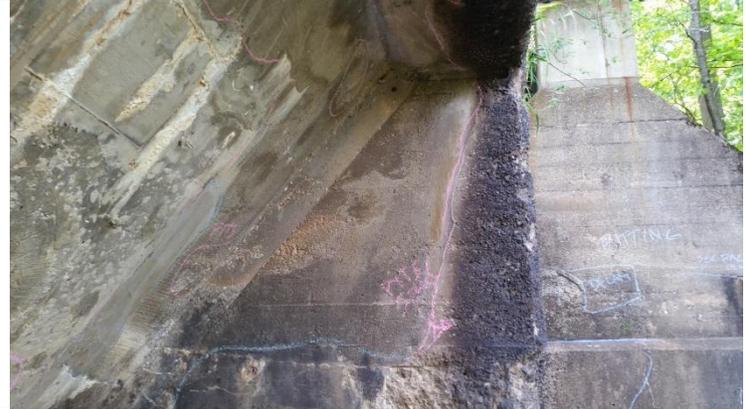
Photo 17

Main Spillway – East Buttress Wall. The upper portion of the east buttress wall shows signs of pitting and spalling. The original concrete substrate is heavily distressed.

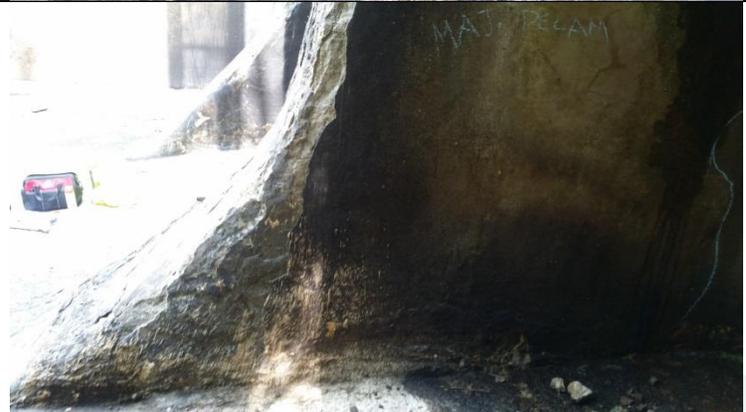
Photo 18

Main Spillway – East Buttress Wall. The bottom portion of the east buttress wall shows signs of delamination and spalling. The original concrete substrate is heavily distressed. Wire mesh reinforcing is exposed.

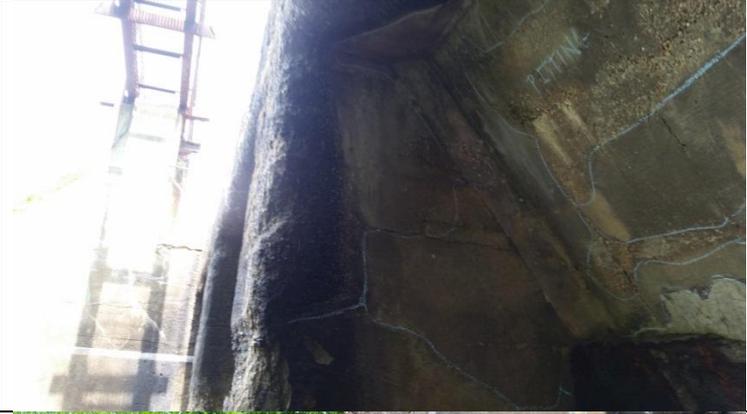
Photo 19

Main Spillway – East Buttress Wall. The upper portion of the east buttress wall shows signs of pitting and spalling. The original concrete is heavily distressed.

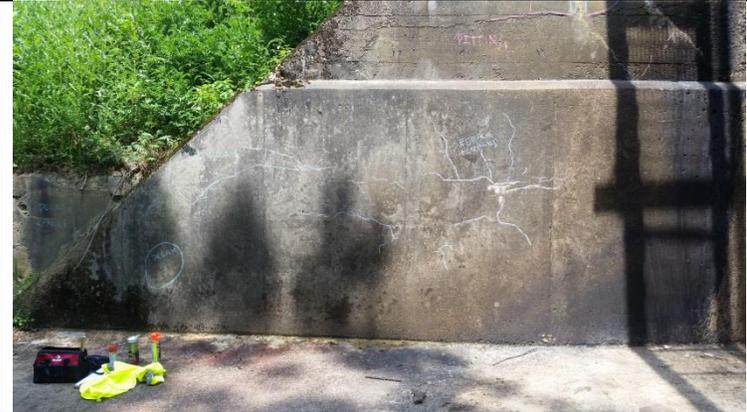
Photo 20

Main Spillway – West Wing Wall. The lower portion of the west wing wall showing some delamination and seepage cracks.

The wing walls of the spillway appear to be generally sound. There are some areas of surface delamination that were detected through hammer sounding, as well as some cracking and spalling, especially near the top of the spillway. GPD recommends that the areas of delaminated concrete be removed, and the surface repaired. Further, spalls near the top of the spillway should be repaired, as well as cracks where seepage is present.

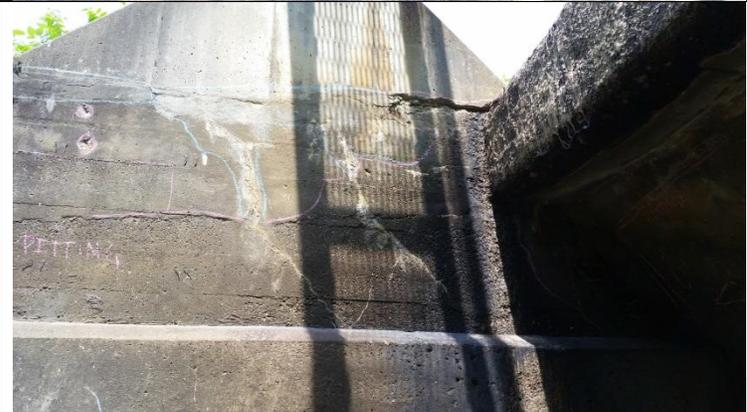
Photo 21

Main Spillway – West Wing Wall. The upper portion of the west wing wall showing some delamination, cracks and spalls. Note the larger spall at the intersection with the spillway.

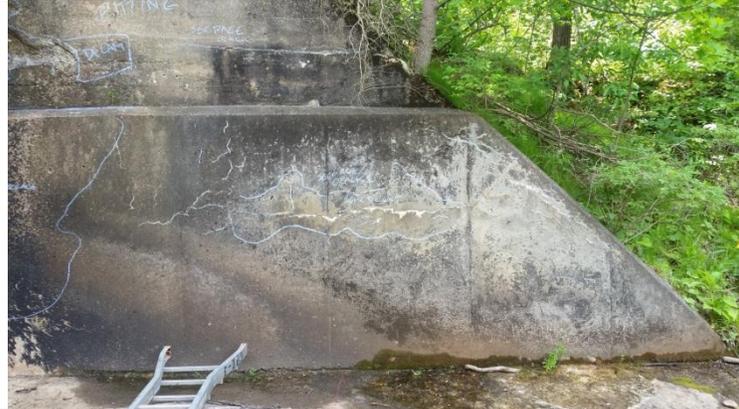
Photo 22

Main Spillway – East Wing Wall. The lower portion of the east wing wall showing some delamination and seepage cracks.

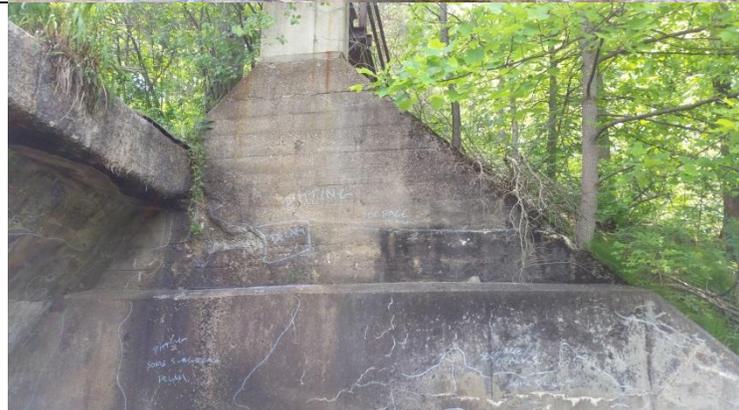
Photo 23

Main Spillway – East Wing Wall. The upper portion of the east wing wall showing some delamination, cracks and spalls. Note the larger spall at the intersection with the spillway.

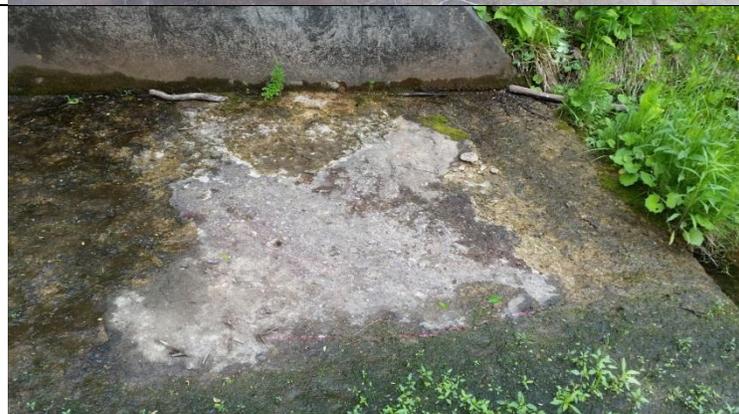
Photo 24

Main Spillway – Apron. The southeast corner of the apron shows signs of deterioration, and sounding with a chain indicates delamination.

The apron slab below the spillway shows signs of surface deterioration, likely due to erosion. However, sounding by chain showed most of the apron appears to be sound. There is one large area showing signs of delaminated surface concrete. GPD recommends that this area be repaired, with the delaminated concrete being removed down to sound concrete and a repair mortar being applied to the prepared surface.

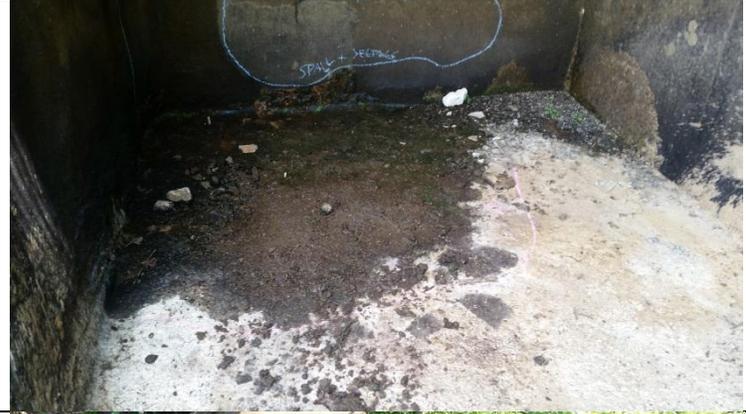
Photo 25

Main Spillway – Apron. The northwest corner of the apron in the easternmost cell shows signs of deterioration. Note the water from seepage. Sounding with a chain indicates delamination.

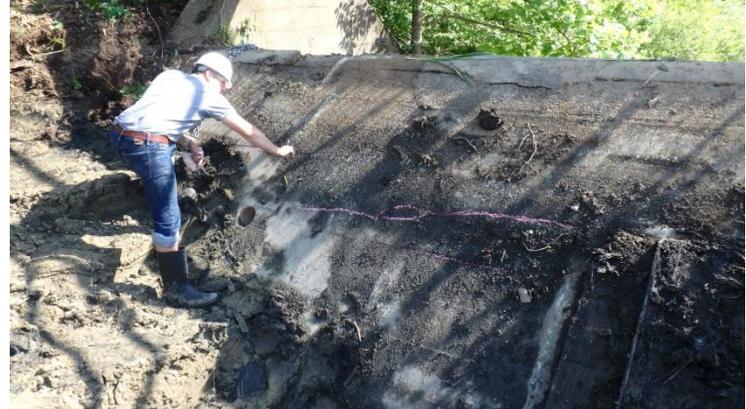
Photo 26

Main Spillway – Upstream Surface. The upstream surface of the spillway appeared to be generally sound, with some cracking present. Clays were present on the upstream side of the dam up to near the spillway elevation.

The upstream side of the spillway appeared to be generally sound. Sounding of the surface with a chain showed little delamination of the surface, while there were some cracks present, which could be areas where seepage occurs. If other repairs are being executed, GPD would recommend that the cracks on the upstream side of the spillway wall be repaired.
