**GPD GROUP®**  
Glaus, Pyle, Schomer, Burns & DeHaven, Inc.

September 1, 2016

2016257.00

**RE: Dam Structural Concrete Conditions Assessment – Upper Hilaka Lake Dam**

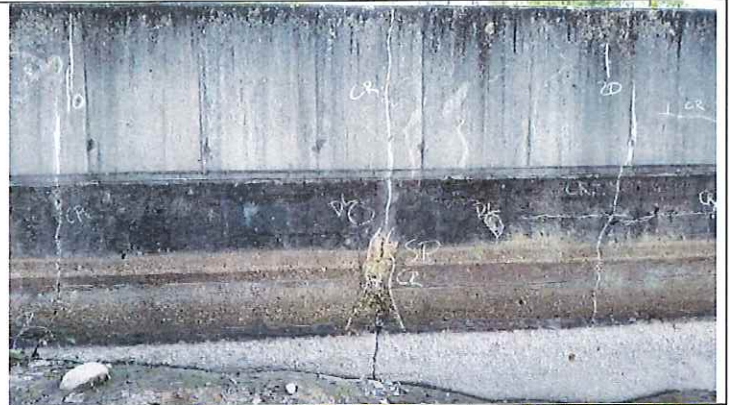
**APPENDIX: REPRESENTATIVE PHOTOS OF THE UPPER HILAKA LAKE DAM:****Photo 1****Description:**

- The concrete "cut off" wall which extends to the west from the main spillway appears to be generally sound, considering the age of the dam. There are a number of vertical cracks which are indicative of shrinkage cracking due to the lack of control joints in the wall. The portions of the wall that are exposed to the retained lake show some signs of spalling.

The concrete "cut off" wall to the west of the main spillway appears to be in good condition. Cracking in this portion of the dam is indicative of shrinkage cracking. There is some spalling present below the spillway elevation, which may be indicative of freeze-thaw damage. There is some delamination and surface spalling above the spillway present, but this damage is superficial and minor in nature. At this time, we would recommend continued observation of the "cut off" wall concrete for additional signs of distress, with no immediate repairs being required. If repairs to the main spillway concrete are performed, repair of spalls and cracks should be considered as added scope. As the spalling below the spillway elevation appears to be freeze-thaw induced, we would suggest that the lake be drawn down every fall to reduce the impact of freeze-thaw on the lower portions of the wall.

Concrete "Cut Off" wall. A representative photo of the lake side of the concrete cut off wall showing cracking indicative of shrinkage cracks (CR) due to no control joints in the wall as well as spalling (SP) near the spillway elevation.

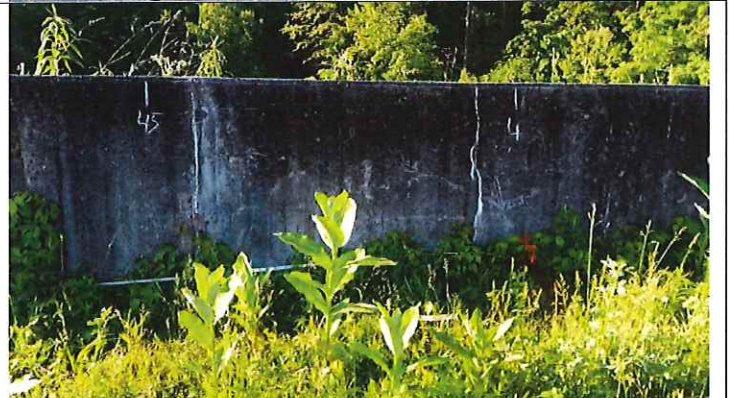
**Photo 2****Description:**

Concrete "Cut Off" wall. A representative photo of the lake side of the concrete cut off wall, with the entire concrete portion of wall above the spillway elevation. Wall shows signs of vertical cracks indicative of shrinkage cracking due to no control joints in the wall.

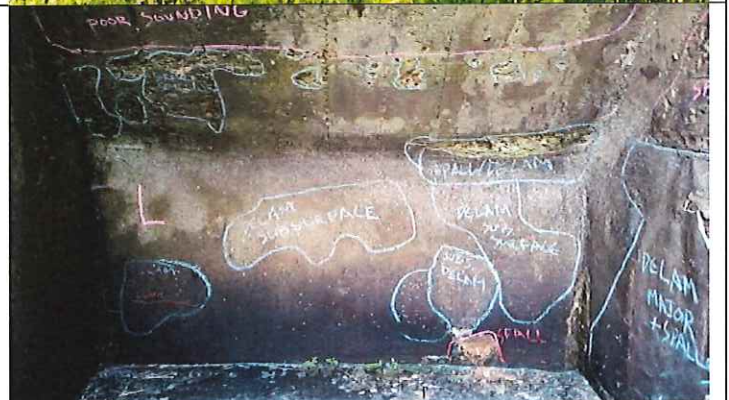
**Photo 3****Description:**

- The concrete spillway condition varies from generally sound to poor. The sloped and vertical surfaces of the concrete spillway show signs of previous repair. Some of the repairs appeared to be delaminating from the original substrate. There are some surface spalls, and cracking throughout. A concrete core was taken from the spillway surface for petrographic analysis.

The spillway concrete showed varying surface conditions. There were areas where previous repairs were made, with some of the repair work showing signs of debonding from the concrete substrate. Other areas appeared to be generally sound. There were some signs of seepage through cracks in the spillway. Petrographic analysis of a core sample taken through the spillway showed few signs of erosion, and low levels of chlorides. GPD recommends that the sloped and vertical surfaces of the spillway downstream of the lake be repaired. Repair would require removal of the existing surface concrete down to sound concrete, with a repair wire mesh & mortar applied to the prepared surface.

Main Spillway – Lower half of westernmost cell. The vertical and sloping surface of the spillway showing surface spalls, delamination, and some cracking.

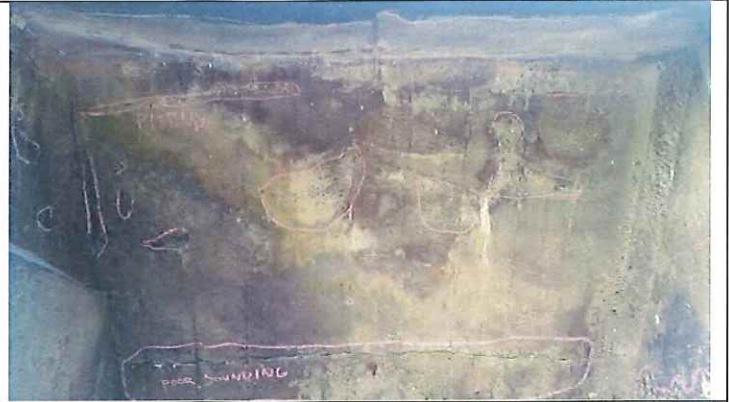
**Photo 4****Description:**

Main Spillway – Upper half of westernmost cell. The sloping surface of the spillway showing surface spalls, delamination, and a large horizontal crack across the cell.

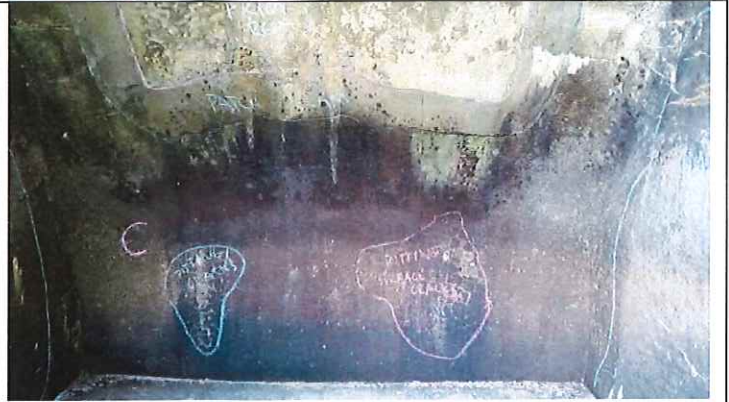
**Photo 5****Description:**

Main Spillway – Lower half of center cell. The vertical and sloping surface of the spillway showing surface pitting and cracks as well as a prior repair showing signs of delamination and debonding from the original substrate.

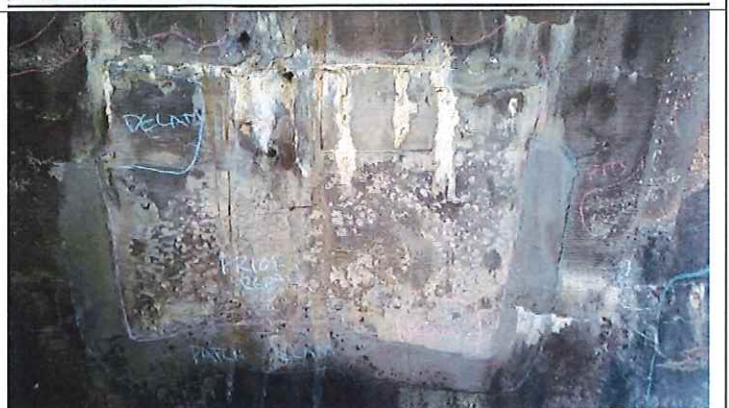
**Photo 6****Description:**

Main Spillway – Upper half of center cell. The sloping surface of the spillway showing surface pitting as well as a prior repair showing signs of delamination and debonding from the original substrate.

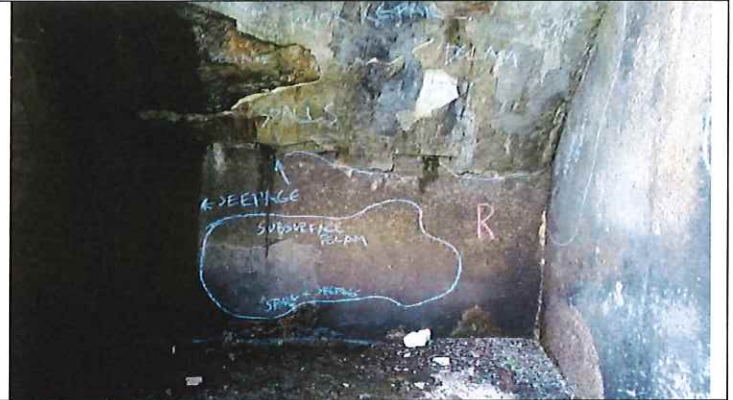
**Photo 7****Description:**

Main Spillway – Lower half of easternmost cell. The vertical and sloping surface of the spillway showing surface delamination and spalling. Seepage is visible in this portion of the spillway.

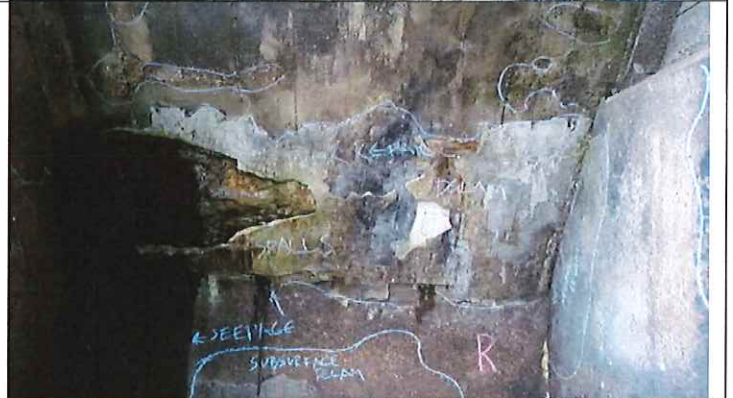
**Photo 8****Description:**

Main Spillway – Center portion of easternmost cell. The vertical and sloping surface of the spillway showing surface delamination of a prior repair and spalling. Seepage is visible in this portion of the spillway.

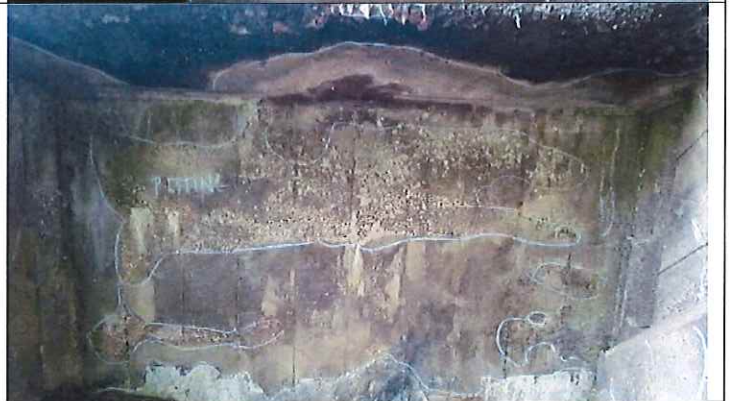
**Photo 9****Description:**

Main Spillway – Upper half of easternmost cell. The sloping surface of the spillway showing surface pitting.

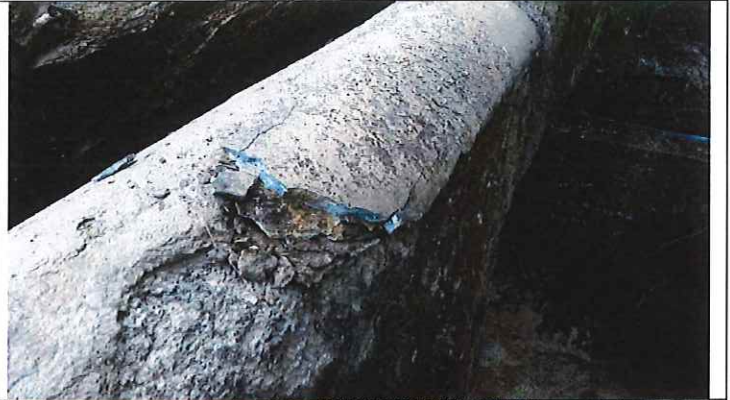
**Photo 10****Description:**

- The top of the spillway showed signs of surface distress. There appeared to be repair concrete present, which appeared to be debonded from the original substrate. Some erosion of the original concrete was present.

The top of the spillway wall showed signs of freeze-thaw damage to the substrate concrete and to previous repairs. Some portions of the top of the spillway have old repairs still in place, but through hammer sounding of the concrete, appear to be debonding from the substrate. GPD recommends that the top portion of the dam spillway be repaired. Similar to the face of the spillway wall, the existing surface would be removed down to sound concrete, and a repair wire mesh & mortar would be applied to the prepared surface. Further, we recommend that the cracks through which water is seeping be repaired and monitored for further seepage.

Main Spillway – Top of spillway. The top surface of the spillway shows signs of freeze thaw damage, with repair material debonding from the original substrate and damage to the original concrete. The vertical surface shows signs of surface pitting and erosion.

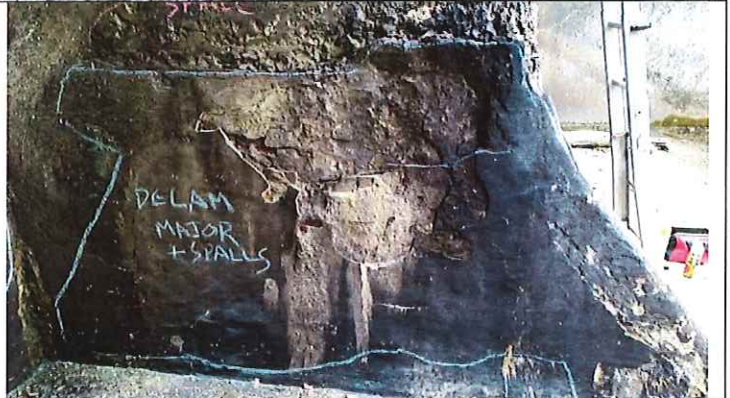
**Photo 11****Description:**

- The two buttress walls were in poor condition. The walls showed signs of previous repairs which appeared to have debonded over time from the original substrate. Embedded steel wire mesh showed signs of corrosion and there was extensive erosion and spalling of the concrete. A concrete core was taken from the eastern most buttress wall and examined for physical characteristics such as cracking.

The two buttress walls of the spillway are in poor condition. Previous surface repairs were in very poor condition, with large areas of repaired concrete debonding from the original substrate. Spalling occurs throughout the buttress walls, and there is corroded wire mesh exposed. A core sample through one of the buttress walls shows signs of freeze-thaw damage, as well as signs of moisture intrusion through the entire width of the wall. GPD recommends that the buttress walls be removed and replaced with new reinforced concrete walls of adequate design. The existing concrete shows signs of freeze-thaw damage down to approximately 4-5" below the surface. Removal of this concrete alone could expose concrete sound enough to apply repair material. However, a repair of this depth would likely necessitate reinforcing being added to the repair, which would be embedded into the existing substrate. Due to the age of the existing concrete, embedding reinforcing into the

Main Spillway – West Buttress Wall. The bottom portion of the west buttress wall shows signs of delamination and spalling. The original concrete substrate is heavily distressed.

existing concrete and bonding it to new concrete would likely create a cathodic cell, and damage to the repair due to corrosion would be accelerated. Our recommendation to remove the whole buttress walls minimizes the risk of recurring repairs being required.

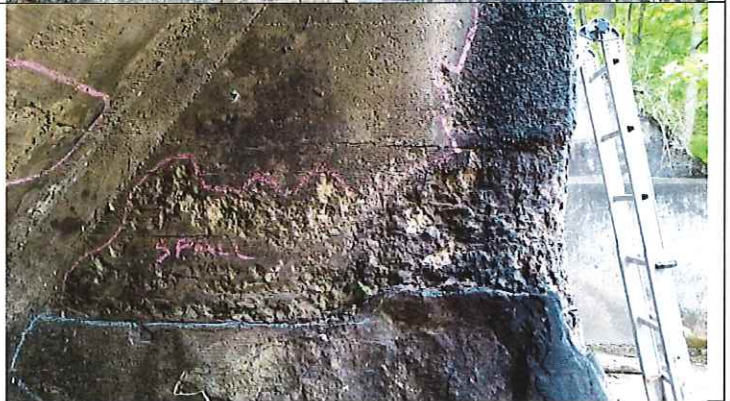
**Photo 12****Description:**

Main Spillway – West Buttress Wall. The middle portion of the west buttress wall shows signs of spalling and cracking. The original concrete substrate is heavily distressed.

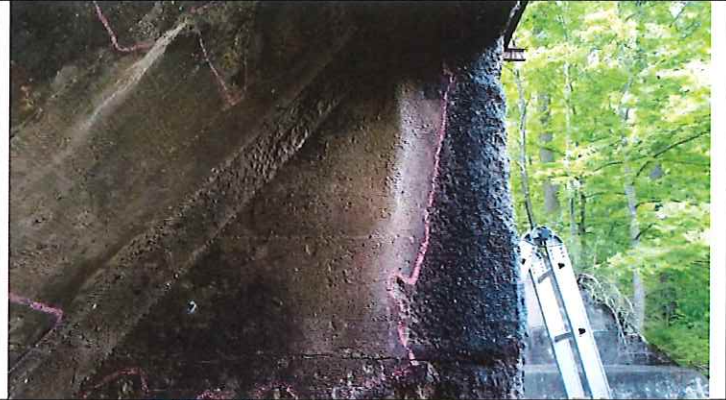
**Photo 13**

Main Spillway – West Buttress Wall. The upper portion of the west buttress wall shows signs of spalling and cracking. The original concrete substrate is heavily distressed.

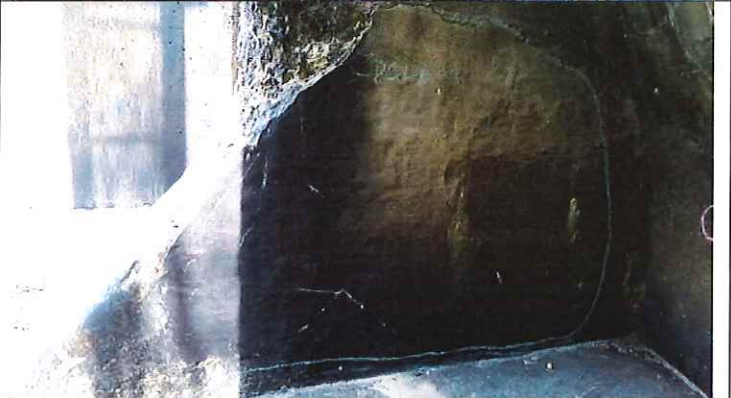
**Photo 14**

Main Spillway – West Buttress Wall. The bottom portion of the west buttress wall shows signs of delamination and spalling. The original concrete substrate is heavily distressed.

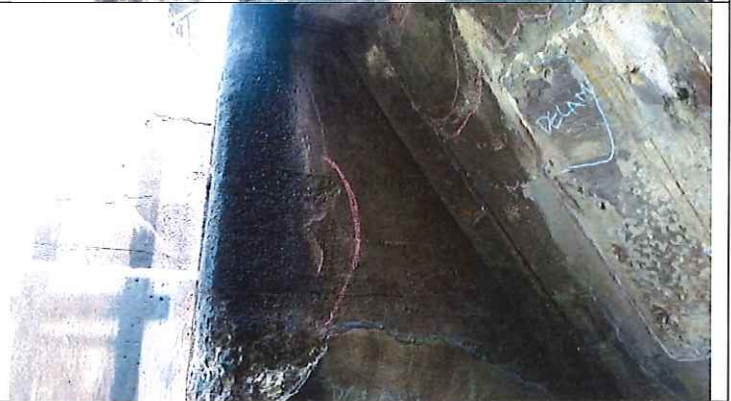
**Photo 15**

Main Spillway – West Buttress Wall. The upper portion of the west buttress wall shows signs of spalling and cracking. The original concrete substrate is heavily distressed.

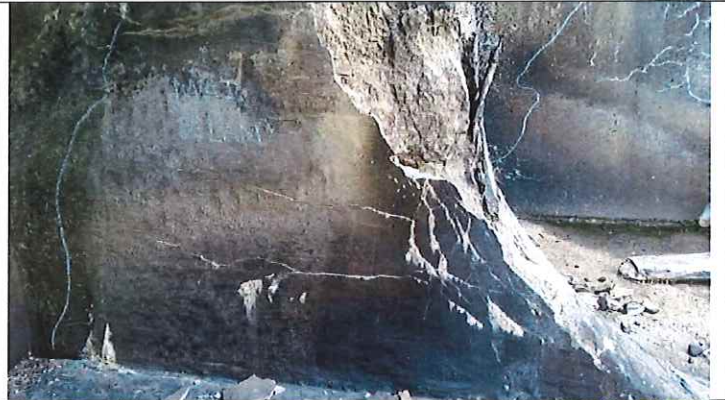
**Photo 16****Description:**

Main Spillway – East Buttress Wall. The bottom portion of the east buttress wall shows signs of delamination and spalling. The original concrete substrate is heavily distressed. Wire mesh reinforcing is exposed.

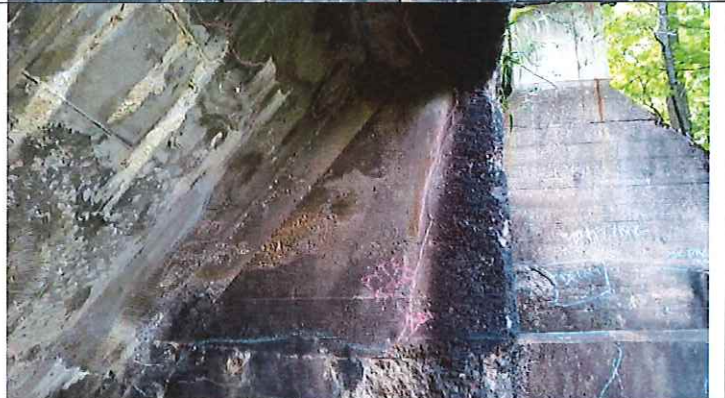
**Photo 17****Description:**

Main Spillway – East Buttress Wall. The upper portion of the east buttress wall shows signs of pitting and spalling. The original concrete substrate is heavily distressed.

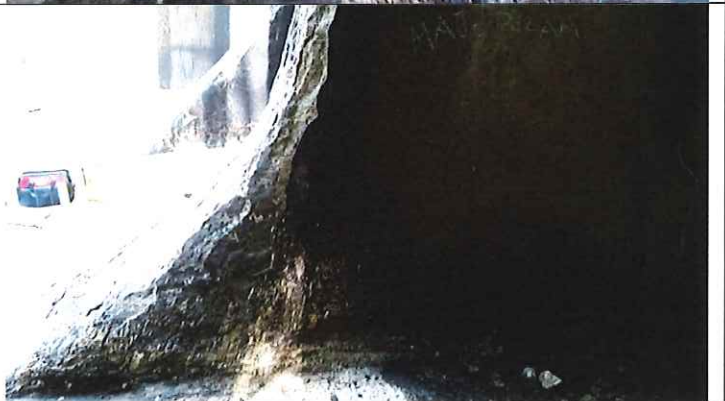
**Photo 18****Description:**

Main Spillway – East Buttress Wall. The bottom portion of the east buttress wall shows signs of delamination and spalling. The original concrete substrate is heavily distressed. Wire mesh reinforcing is exposed.

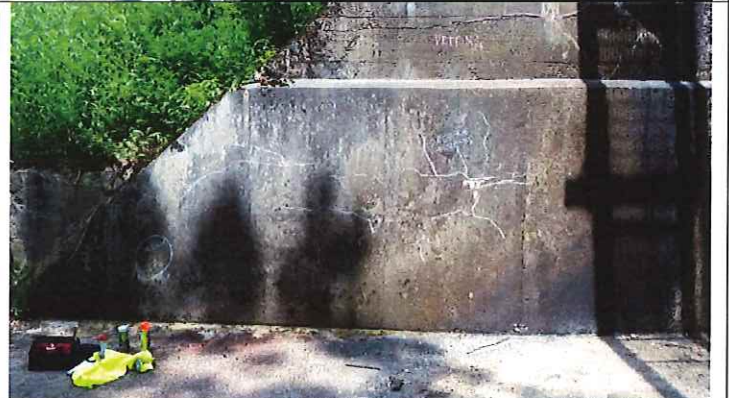
**Photo 20****Description:**

- The side walls showed some cracking and spalling, but appeared to be generally sound. Near the spillway elevation, more cracking and spalling was observed.

Main Spillway – West Wing Wall. The lower portion of the west wing wall showing some delamination and seepage cracks.

The wing walls of the spillway appear to be generally sound. There are some areas of surface delamination that were detected through hammer sounding, as well as some cracking and spalling, especially near the top of the spillway. GPD recommends that the areas of delaminated concrete be removed, and the surface repaired. Further, spalls near the top of the spillway should be repaired, as well as cracks where seepage is present.

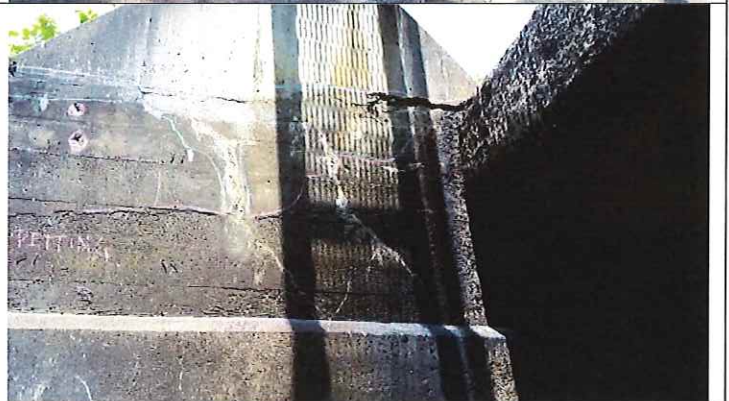
**Photo 21****Description:**

Main Spillway – West Wing Wall. The upper portion of the west wing wall showing some delamination, cracks and spalls. Note the larger spall at the intersection with the spillway.

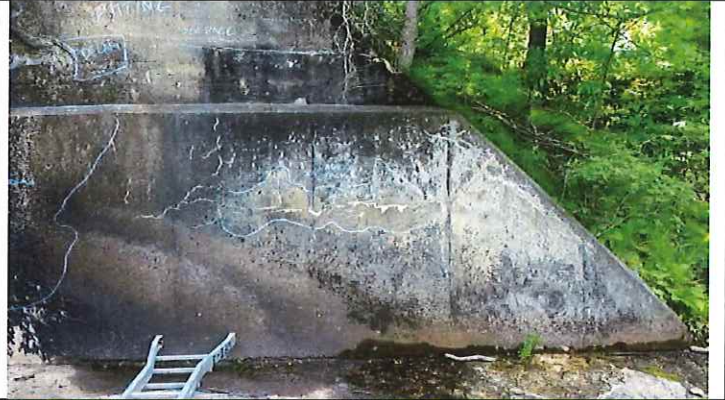
**Photo 22**

Main Spillway – East Wing Wall. The lower portion of the east wing wall showing some delamination and seepage cracks.

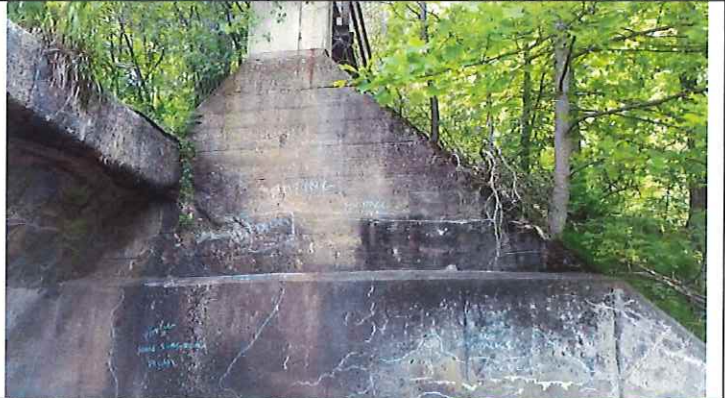
**Photo 23**

Main Spillway – East Wing Wall. The upper portion of the east wing wall showing some delamination, cracks and spalls. Note the larger spall at the intersection with the spillway.

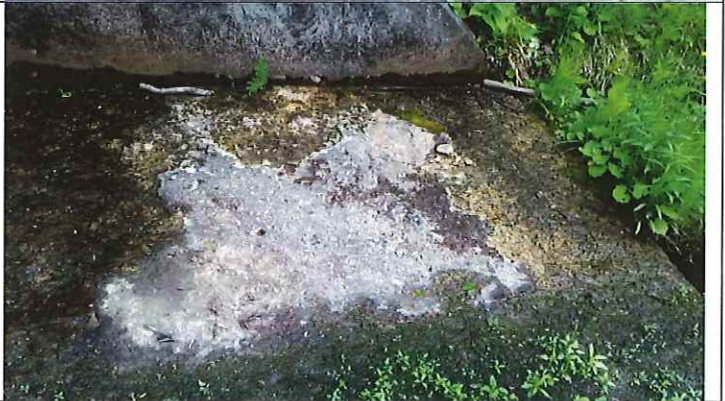
**Photo 24**

- The apron at the bottom of the dam appeared to be generally sound. There was some areas of surface delamination. Some surface erosion has occurred, and standing water was present in some areas at the time of our visit. A concrete core was taken from the apron and examined for physical characteristics.

Main Spillway – Apron. The southeast corner of the apron shows signs of deterioration, and sounding with a chain indicates delamination.

The apron slab below the spillway shows signs of surface deterioration, likely due to erosion. However, sounding by chain showed most of the apron appears to be sound. There is one large area showing signs of delaminated surface concrete. GPD recommends that this area be repaired, with the delaminated concrete being removed down to sound concrete and a repair mortar being applied to the prepared surface.

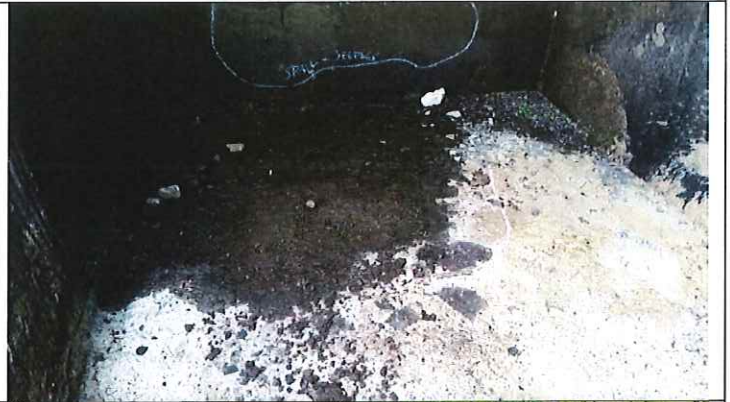
**Photo 25****Description:**

Main Spillway – Apron. The northwest corner of the apron in the easternmost cell shows signs of deterioration. Note the water from seepage. Sounding with a chain indicates delamination.

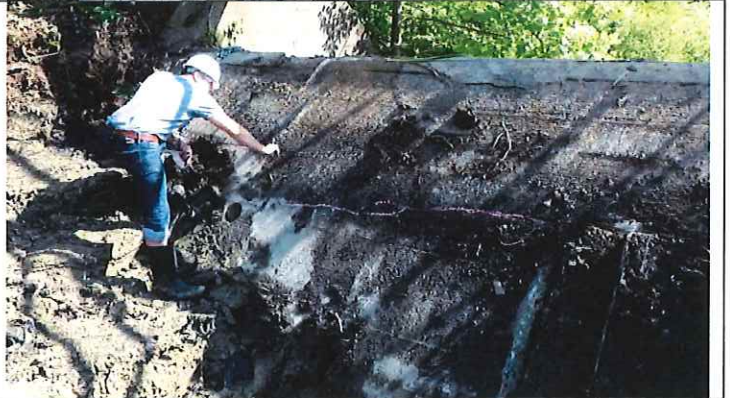
**Photo 26****Description:**

- The backside of the spillway wall appeared to be generally sound. Approximately 6 feet of soil/sediment was removed from the upstream side of the dam to allow access for observation. There was some cracking, but little surface delamination as indicated by the sounding tests performed.

Main Spillway – Upstream Surface. The upstream surface of the spillway appeared to be generally sound, with some cracking present. Clays were present on the upstream side of the dam up to near the spillway elevation.

The upstream side of the spillway appeared to be generally sound. Sounding of the surface with a chain showed little delamination of the surface, while there were some cracks present, which could be areas where seepage occurs. If other repairs are being executed, GPD would recommend that the cracks on the upstream side of the spillway wall be repaired.
