September 1, 2016
2016257.00

RE: Dam Structural Concrete Conditions Assessment

Lower Camp Crowell Lake Dam

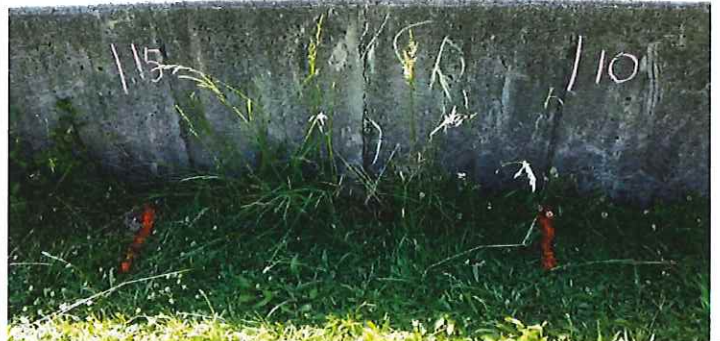
Photo 1

- The concrete "cut off" wall which extends to the west from the Millhouse appears to be generally sound, considering the age of the dam. There are a number of vertical cracks which are indicative of shrinkage cracking due to the lack of control joints in the wall. The portions of the wall that are exposed to the retained lake show some signs of spalling.

The concrete "cut off" wall to the north of the main spillway appears to be in good condition. Cracking in this portion of the dam may be indicative of shrinkage cracking. There is some spalling present on the retained side of the wall below the spillway elevation, which may be indicative of freeze-thaw damage. At this time, we would recommend continued observation of the "cut off" wall concrete for additional signs of distress, with no immediate repairs being required. If repairs to the main spillway concrete are undertaken, repair of cracks should be considered as added scope. As the spalling below the spillway elevation appears to be freeze-thaw induced, we would suggest that the lake be drawn down every fall to reduce the impact of freeze-thaw on the lower portions of the wall.

Concrete "Cut Off" wall. A representative photo of the downstream side of the concrete cut off wall showing cracking (CR) indicative of shrinkage cracks due to no control joints in the wall.

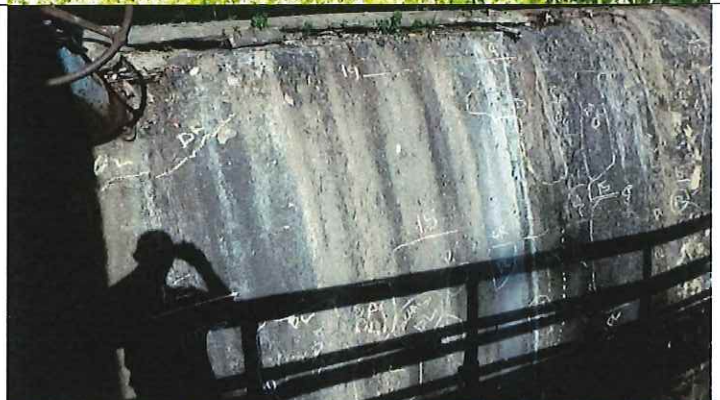
Photo 2

- The ogee spillway concrete surface is in poor condition. The surface shows extensive signs of erosion, with extensive surface pitting, delaminated concrete repairs, and spalls throughout the surface.

Ogee spillway. The top portion of the north end of the ogee spillway. The concrete surface showed signs of spalling (SP), delamination (DL), and cracking (CR).

The ogee spillway concrete showed varying surface conditions. There were areas where previous repairs were made, with some of the repair work showing signs of debonding from the concrete substrate. In some areas the original concrete substrate was spalling away. A concrete core sample was taken from the spillway for petrographic analysis. This concrete core indicated cracking in the repair materials applied in the 1980s. Given the condition of the surface and existing repairs, GPD recommends that the surface of the ogee spillway be repaired. Repair would entail removal of the existing repair materials and a portion of the original concrete down to sound concrete. A repair wire mesh & mortar would be applied to the prepared spillway surface.

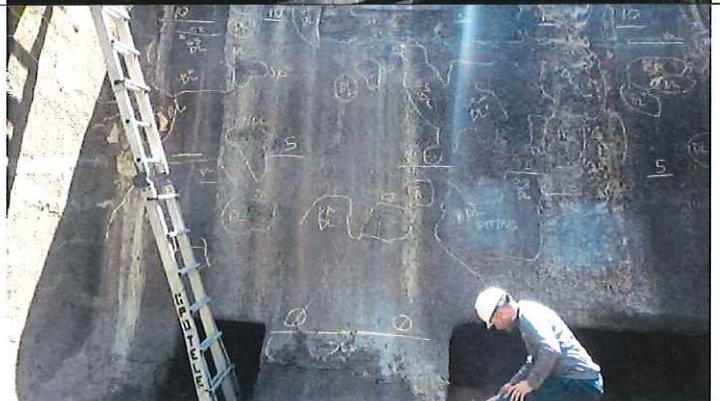
Photo 3

Ogee spillway. The bottom portion of the north end of the ogee spillway. The concrete surface showed signs of spalling (SP), delamination (DL), and cracking (CR).

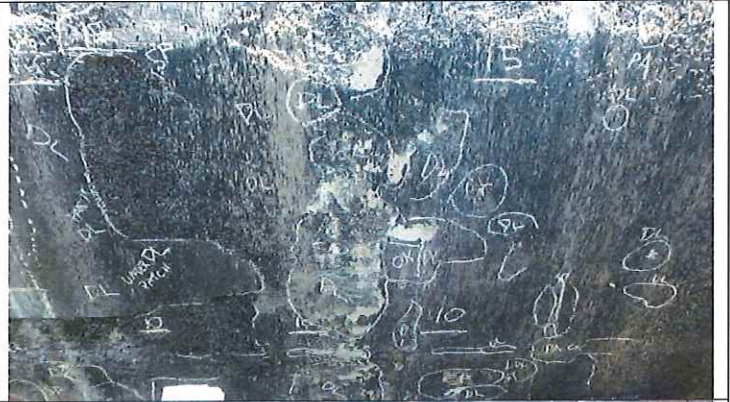
Photo 4**Description:**

Ogee spillway. The top portion of the center section (directly north of the splash wall) of the ogee spillway. The concrete surface showed signs of spalling (SP), delamination (DL), and cracking (CR).

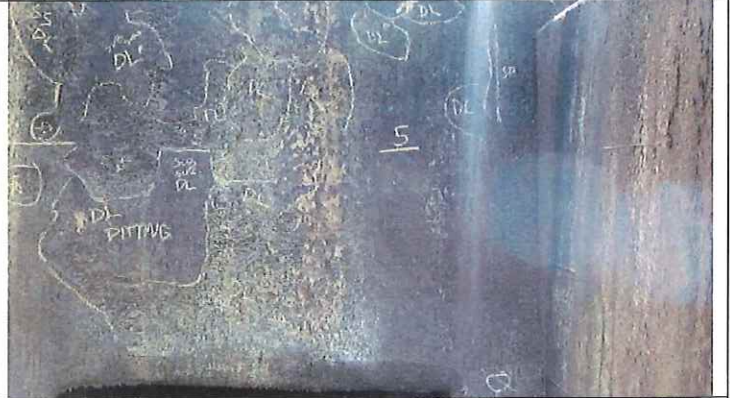
**Photo 5****Description:**

Ogee spillway. The bottom portion of the center section (directly north of the splash wall) of the ogee spillway. The concrete surface showed signs of spalling (SP), delamination (DL), and cracking (CR).

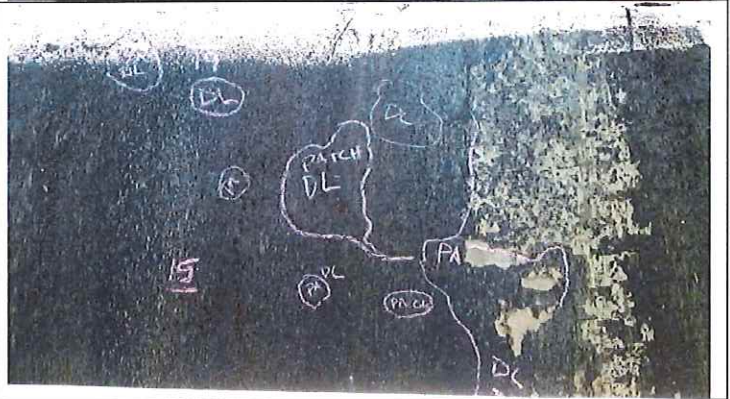
**Photo 6****Description:**

Ogee spillway. The top portion of the east section (directly south of the splash wall) of the ogee spillway. The concrete surface showed signs of spalling (SP), delamination (DL), and cracking (CR).

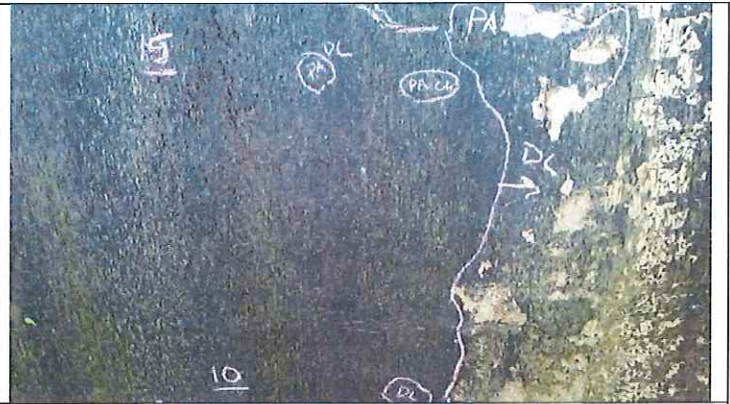
Photo 7**Description:**

Ogee spillway. The center portion of the east section (directly south of the splash wall) of the ogee spillway. The concrete surface showed signs of spalling (SP), delamination (DL), and cracking (CR).

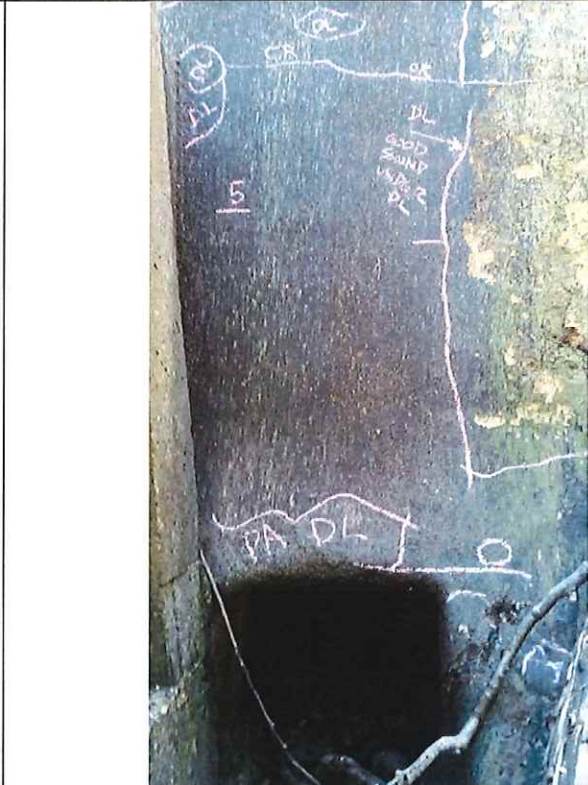
**Photo 8****Description:**

Ogee spillway. The bottom portion of the east section (directly south of the splash wall) of the ogee spillway. The concrete surface showed signs of spalling (SP), delamination (DL), and cracking (CR).

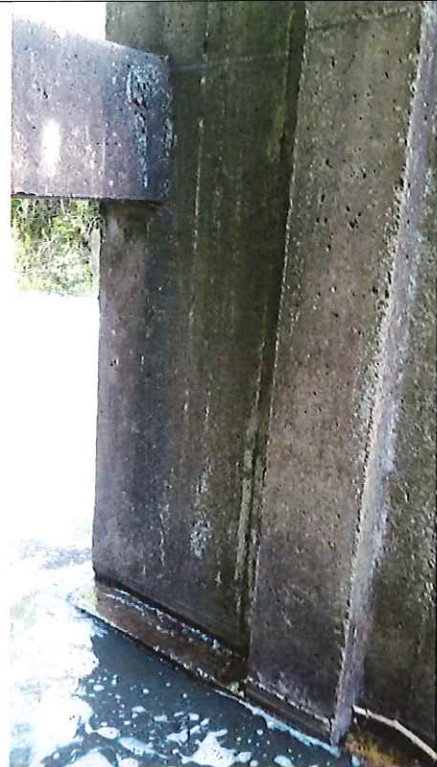
Photo 9**Description:**

- The splash wall, which was part of the 1979 improvements to the dam, was in good condition. The surface showed some irregularity, but this did not appear to be due to deterioration of the surface.

Splash wall. Representative photo of the splash wall. Some surface imperfection, but generally sound concrete.

The splash wall which was installed during the 1980s appeared to be in good condition. Superficial surface imperfections were observed, but at this time, no repair work should be required.

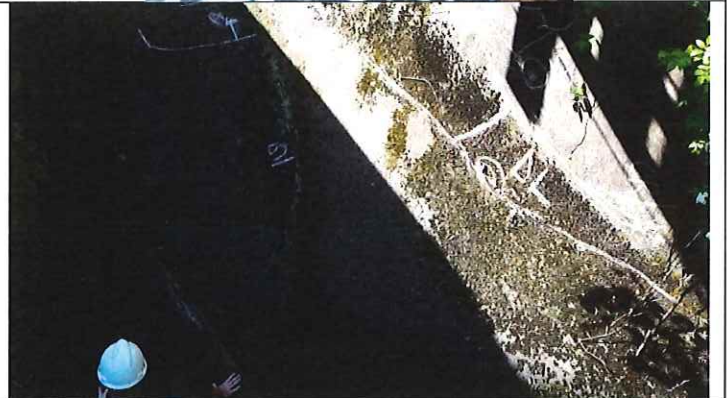
**Photo 10****Description:**

- The chute on the eastern portion of the dam is in poor condition. The surface of the chute showed signs of delaminated concrete on the surface, with cracking throughout. Toward the bottom half of the chute, a hole has opened up, and an area of soil approximately 4'X10' has washed out from underneath the chute. The headwall at the top of the chute shows signs of spalling where it intersects the ogee spillway.

Chute. The bottom portion of the chute. Surface shows signs of delamination (DL), cracking, and spalling (SP).

The chute on the south end of the dam is in poor condition. The concrete condition varies along the length of the chute, with cracking on the vertical surface of the chute, and spalling and delamination present on the bottom surface of the chute. A hole has formed in the chute, with the earth supporting the chute eroding away, leaving a void approximately 4 feet wide by 10 feet long. GPD recommends repair of the chute, but further investigation should be executed to determine the full extent of the repairs needed. At minimum, the vertical surfaces of the chute should be repaired, with existing repair material and original concrete removed down to sound concrete. A concrete core taken from the chute wall indicates freeze-thaw distress down to 7 inches below the surface. GPD recommends that the concrete be removed to at least this depth for surface preparation. The thickness of the existing chute walls was unknown to GPD at the time of this inspection, and further investigation of the chute could lead to a recommendation of full removal and replacement of the chute. Additional core samples should be taken to determine the original thickness of the concrete structure to determine if a surface repair will be effective, or if full removal or replacement is required. In addition, the void that has formed below the chute requires attention. All loose material that has been weakened by washing out of the soil over time should be removed, the void should be filled with lean concrete, and the chute atop this fill should be repaired.

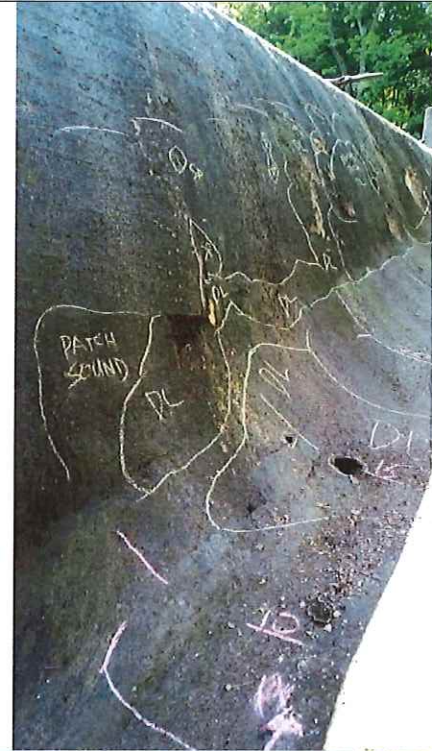
Photo 11**Description:**

Chute. The lower center portion of the chute looking to the east wall of the chute. Surface shows signs of delamination (DL), cracking, and spalling (SP). Note the hole in the bottom of the chute near the 15' mark. The arrow at the bottom of the photo represents the approximate lower extent of the void below the chute.

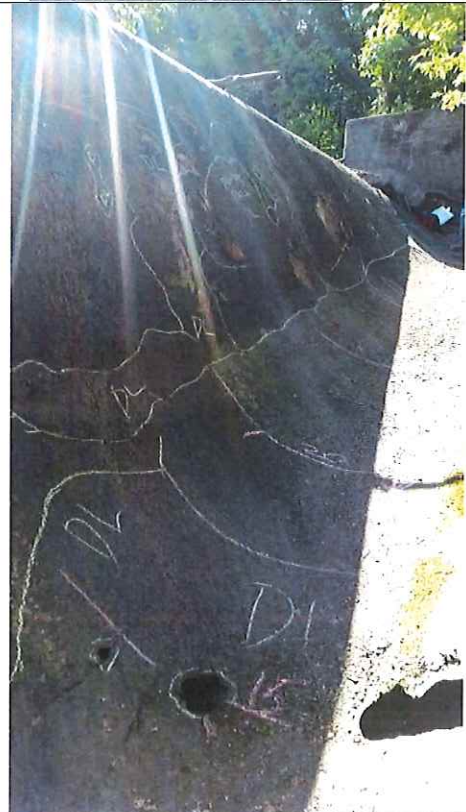
**Photo 12****Description:**

Chute. The upper center portion of the chute looking to the east wall of the chute. Surface shows signs of delamination (DL), cracking, and spalling (SP). Note the hole in the bottom of the chute near the 15' mark.

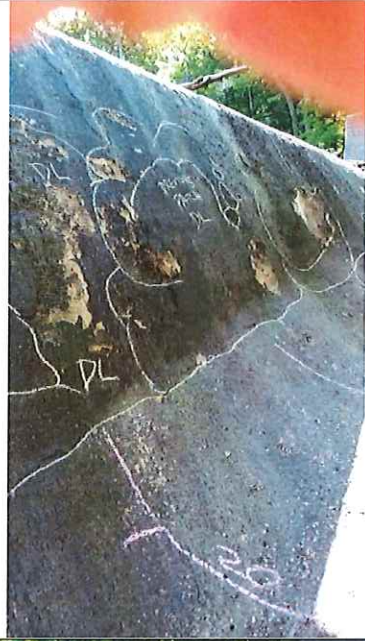
Photo 13**Description:**

Chute. The upper portion of the chute looking to the east wall of the chute. Surface shows signs of delamination (DL), cracking, and spalling (SP).

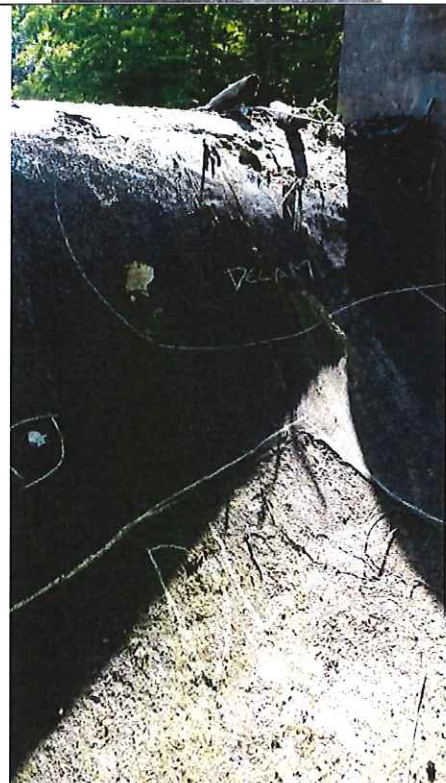
**Photo 14****Description:**

Chute. The top of the chute looking to the east wall of the chute. Surface shows signs of delamination (DL), cracking, and spalling (SP).

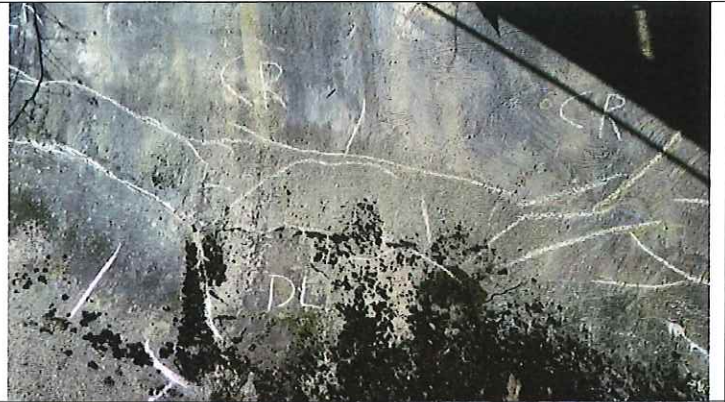
Photo 15**Description:**

Chute. A representative photo of the lower portion of the west wall of the chute. The surface shows signs of delamination (DL), cracking (CR).

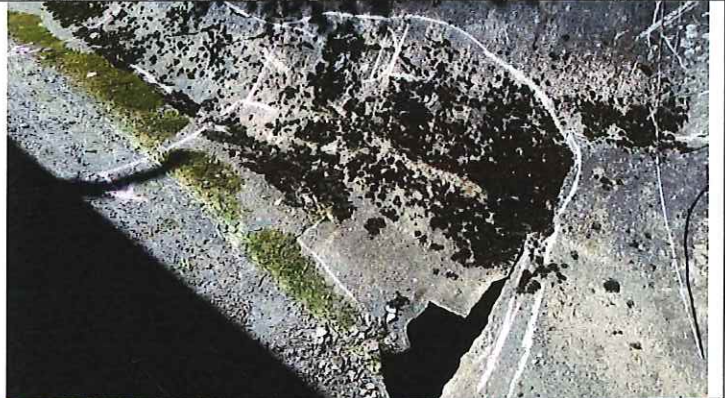
**Photo 16****Description:**

Chute. A photo of the west wall of the chute. The surface shows signs of delamination (DL), cracking (CR). Notice the opening in the bottom of the chute in the foreground of the photo.

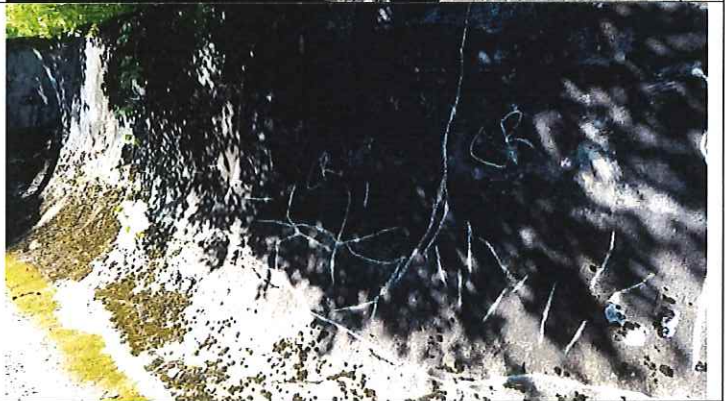
**Photo 17****Description:**

Chute. A representative photo of the upper portion of the west wall of the chute. The surface shows signs of delamination (DL), cracking (CR).

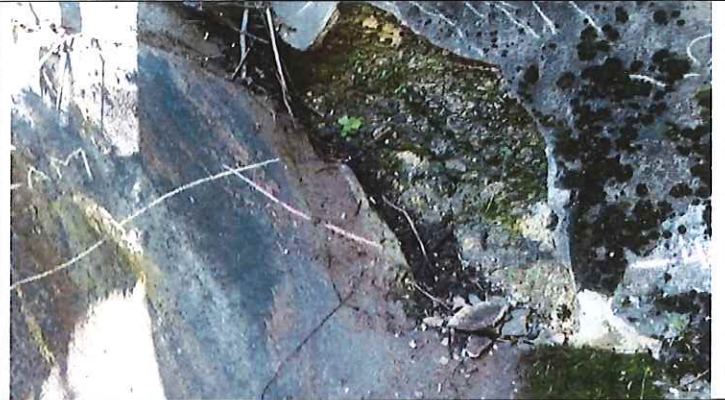
Photo 18**Description:**

Chute. Spall at the top of the chute.

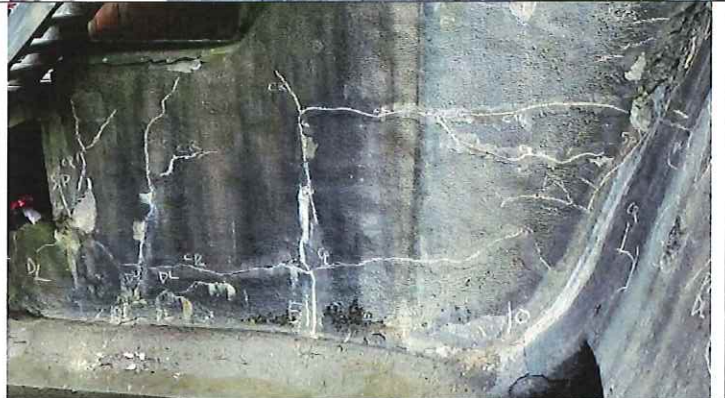
**Photo 19****Description:**

- The wall supporting the south wall of the millhouse is in fair to poor condition. The outside face of the wall has repair mortar on the surface, which showed signs of cracking. The repair material on the inside face of the wall showed signs of debonding from the original substrate. A concrete core was taken from the inside of the wall. The portion of the wall nearest the wheel showed greater

Millhouse. Lower portion of the outside face of the south millhouse wall. Wall shows signs of cracking (CR), delamination (DL), and spalling (SP).

The millhouse foundation walls are in fair to poor condition. The south wall supporting the millhouse showed signs of cracking in the previously made surface repairs, and the original substrate showed signs of freeze-thaw damage to depths of approximately 4 inches on the interior face of the wall. The wall supporting the east wall of the millhouse is in fair condition, with prior surface repairs debonding from the original concrete. GPD recommends that the millhouse walls be repaired, with further investigation required to determine the extent of the repairs. For a surface repair, extensive amounts of concrete would need to be removed, and this further investigation could lead to the recommendation that the south wall be removed in its entirety and replaced. This would cause some challenges as the millhouse sits atop these walls, and support of the millhouse during replacement would need to be designed.

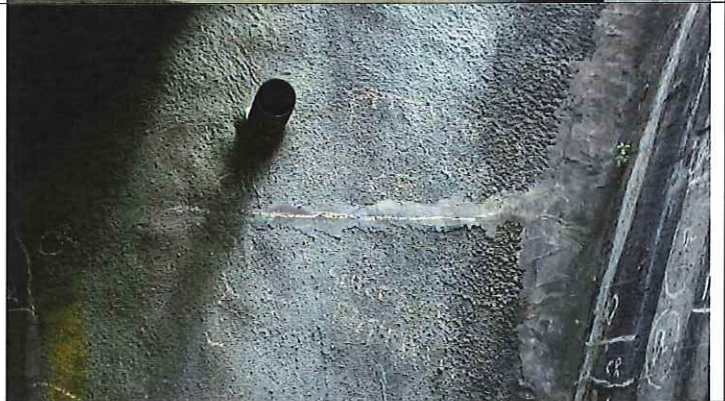
**Photo 20****Description:**

Millhouse. Upper portion of the outside face of the south millhouse wall. Wall shows signs of cracking (CR), delamination (DL), and pitting. Portions of the wall above this level were not accessible by ladder.

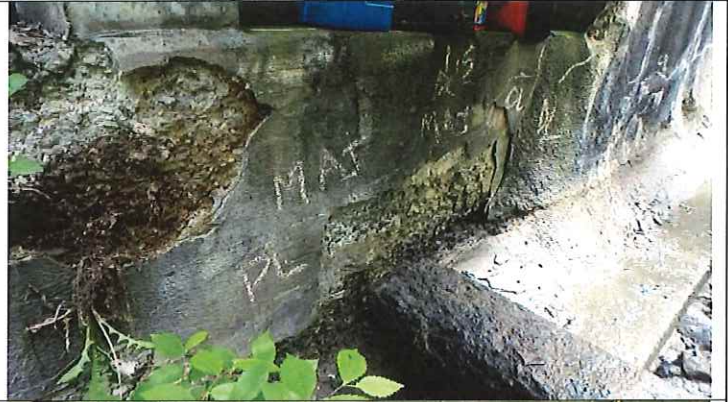
Photo 21**Description:**

signs of distress, with surface spalling, and debonding of repair material. Weeds were found to be growing in cracks in the wall.

Millhouse. Portion of the wall below the lower patio of the millhouse between the wheel and millhouse. Wall shows delamination (DL) and spalling. The substrate is eroding, and vegetation is growing in the spalls and cracks.

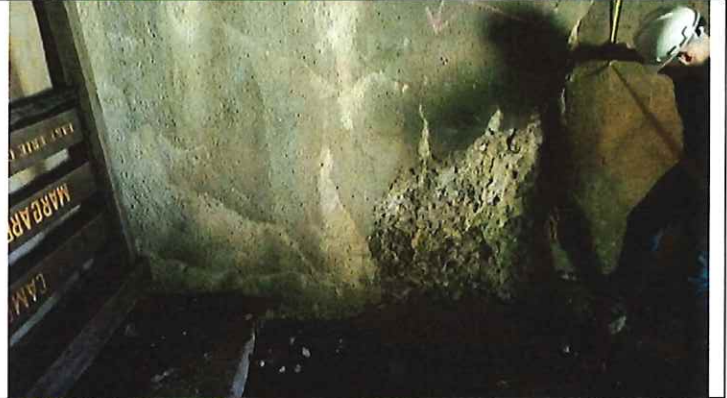
**Photo 22****Description:**

Millhouse. Lower portion of the interior surface of the south millhouse wall. Wall shows delamination of surface repairs as well as heavy deterioration of the substrate.

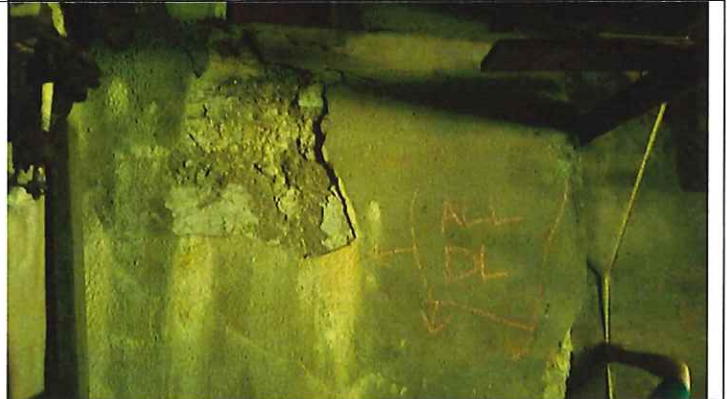
**Photo 23****Description:**

Millhouse. Upper portion of the interior surface of the south millhouse wall. Wall shows delamination of surface repairs as well as heavy deterioration of the substrate.

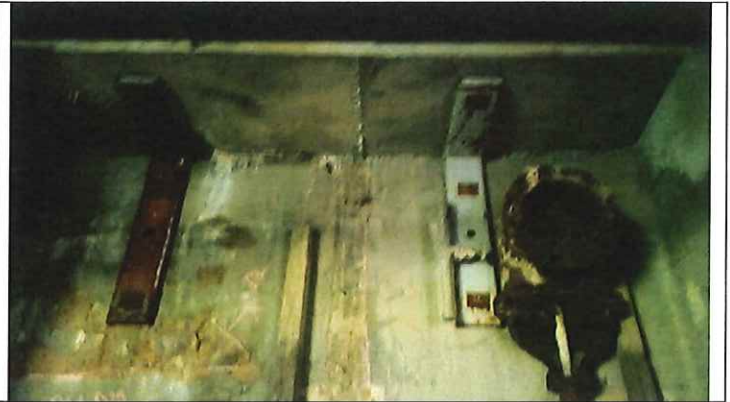
Photo 24**Description:**

- The wall supporting the east wall of the millhouse is in fair condition. There are previous surface repairs that show signs of debonding from the original substrate. It should also be noted that there is a visible gap at the top of the wall below the wood patio that allows rainfall surface runoff water to enter the basement of the millhouse.
- While the level of the lake was lowered to allow inspection of the spillway surface, the upstream side of the dam was not accessible and was not inspected at the time of our visit.
- The hollow areas of the dam below the ogee spillway were not accessible, and were not inspected.

Millhouse. Upper portion of the interior surface of the east millhouse wall. Wall shows delamination of surface repairs.
